## Phase II Soil Sampling

**Assessor's Parcel Numbers  
646-310-17, 646-240-30, and  
646-080-26, -27, -28, -29, -31, -32,  
and -33  
Vicinity of 9300 Otay Mesa Road  
San Diego, California**

March 2, 2016  
Project Number: 01203535.32

**Subject: Phase II Soil Sampling (Assessment)**

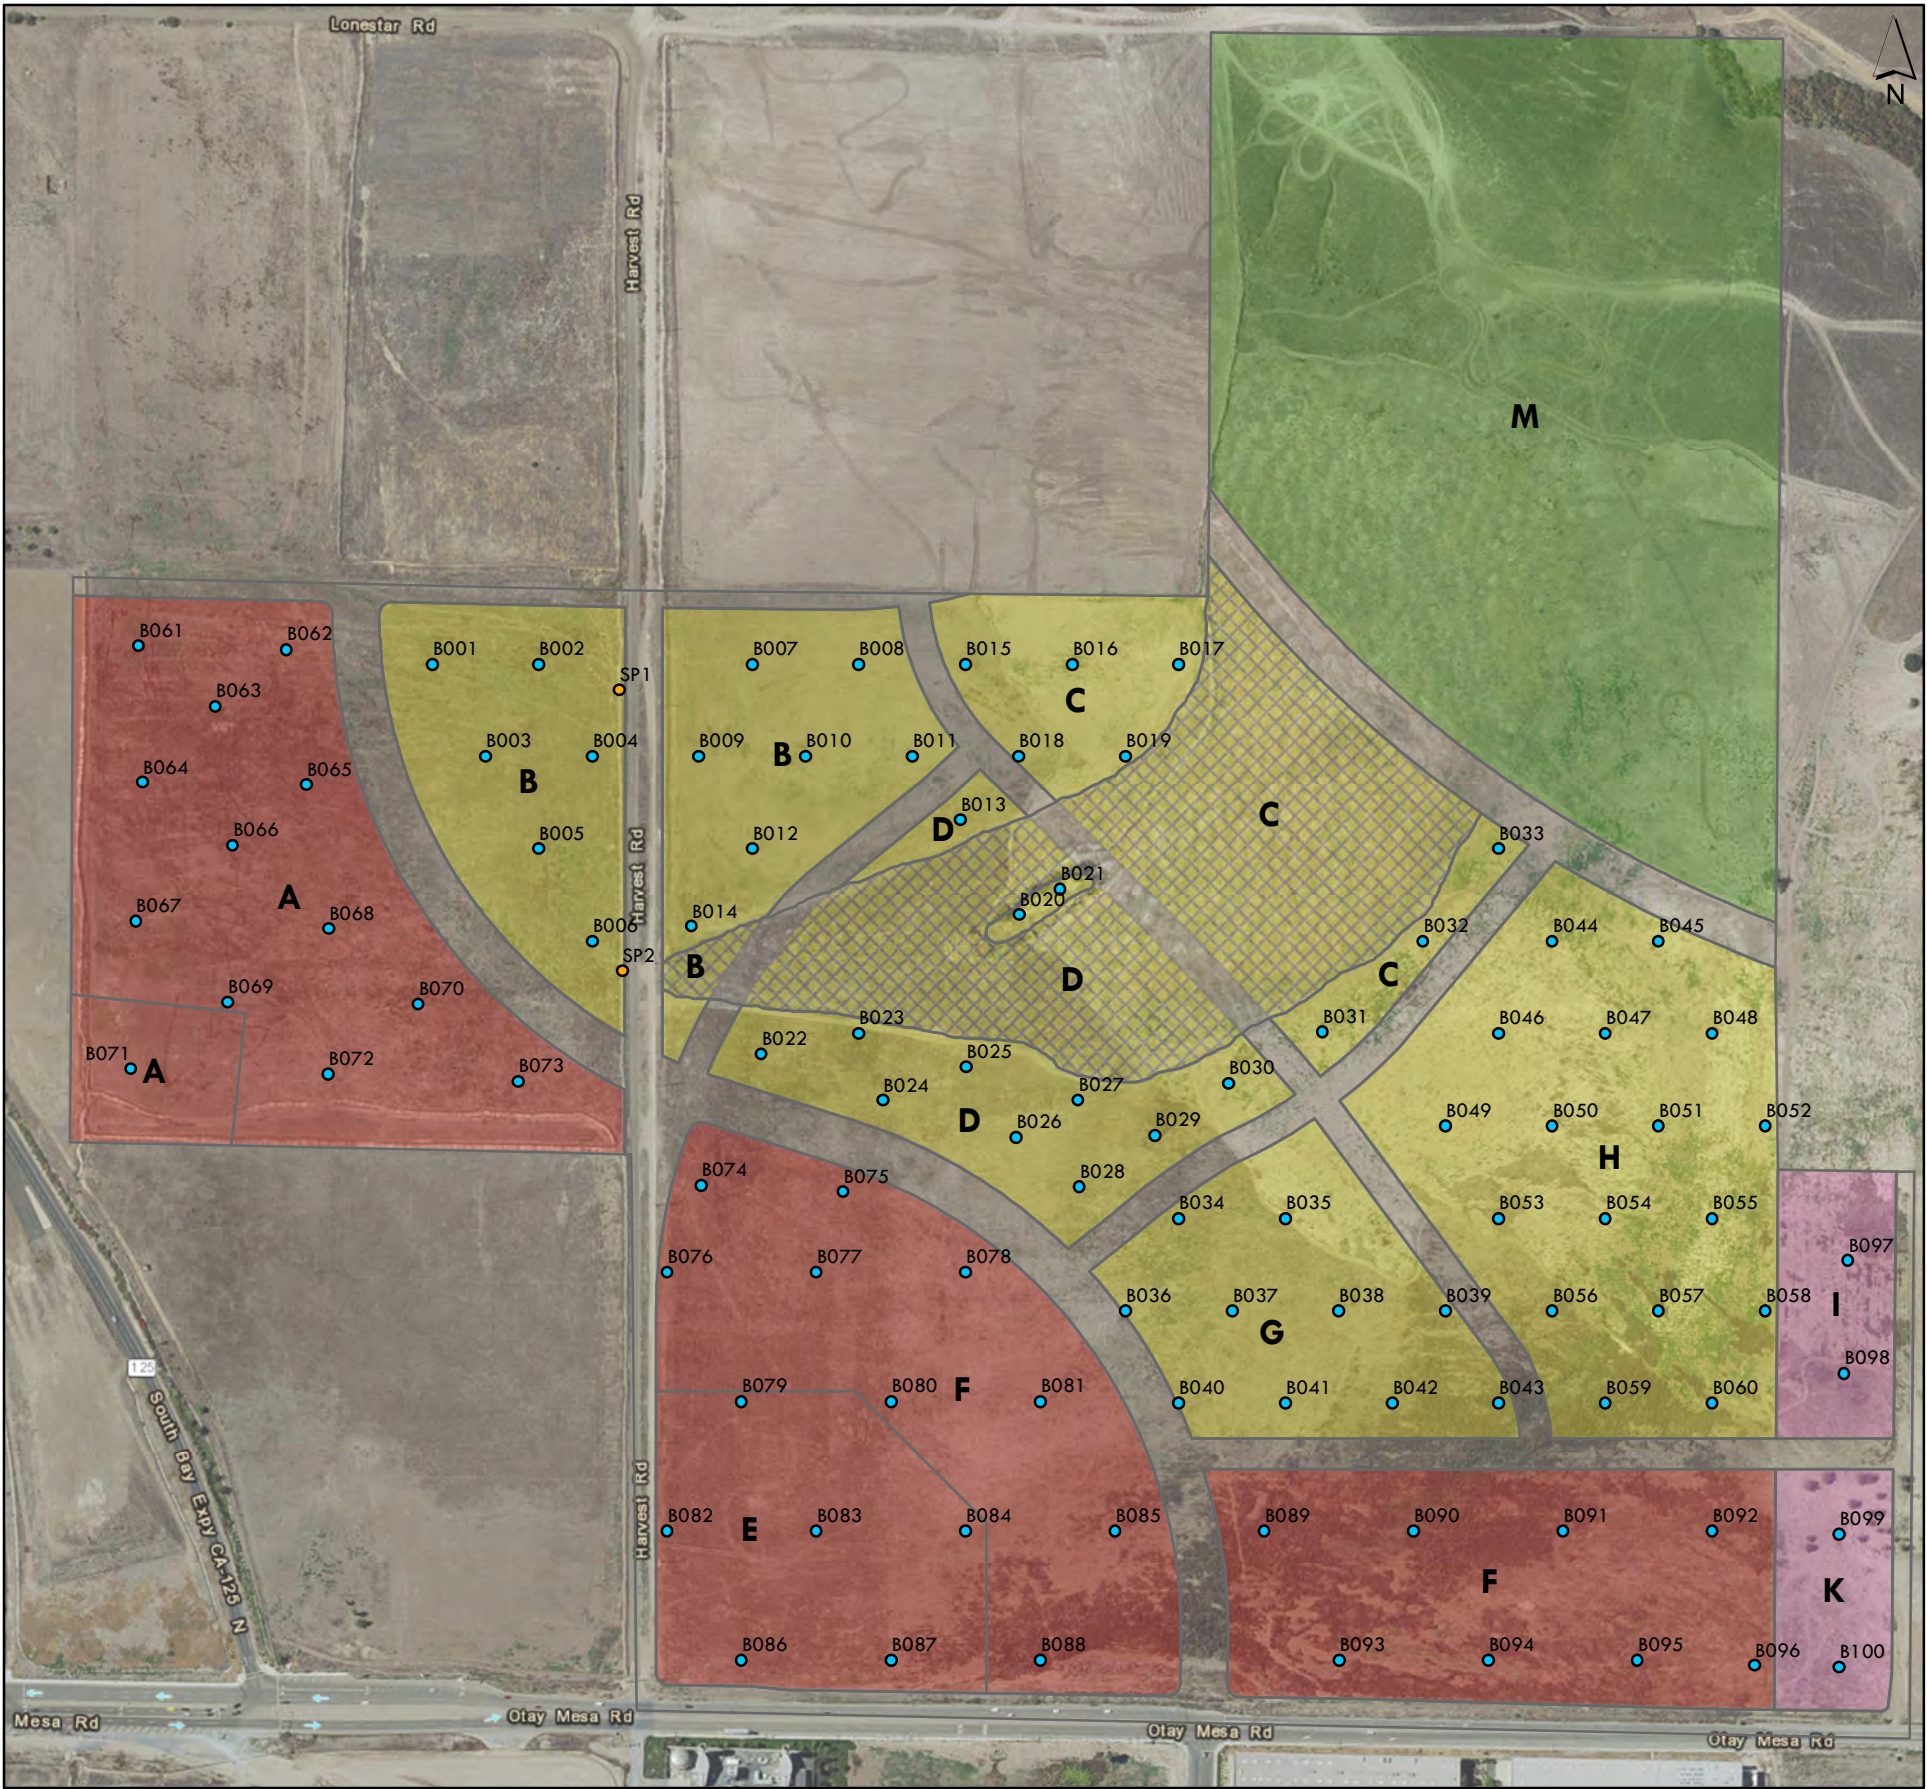
- Approximate SCS Soil Boring Locations, advanced on December 21, 2015 and January 14, 2016
- Approximate SCS Soil Berm sampling locations, collected January 14, 2016

- B/C/D Central Mesa Area
- A/E/F Mixed-use with commercial emphasis
- M Open Space Easement
- B/C/D G/H Mixed-use with residential emphasis
- I/K Technology Business Park

Prior to field activities, SCS designed a soil sampling program and soil boring locations taking into account the Client's proposed future Site land-uses and historical Site land-uses (Figure 2).

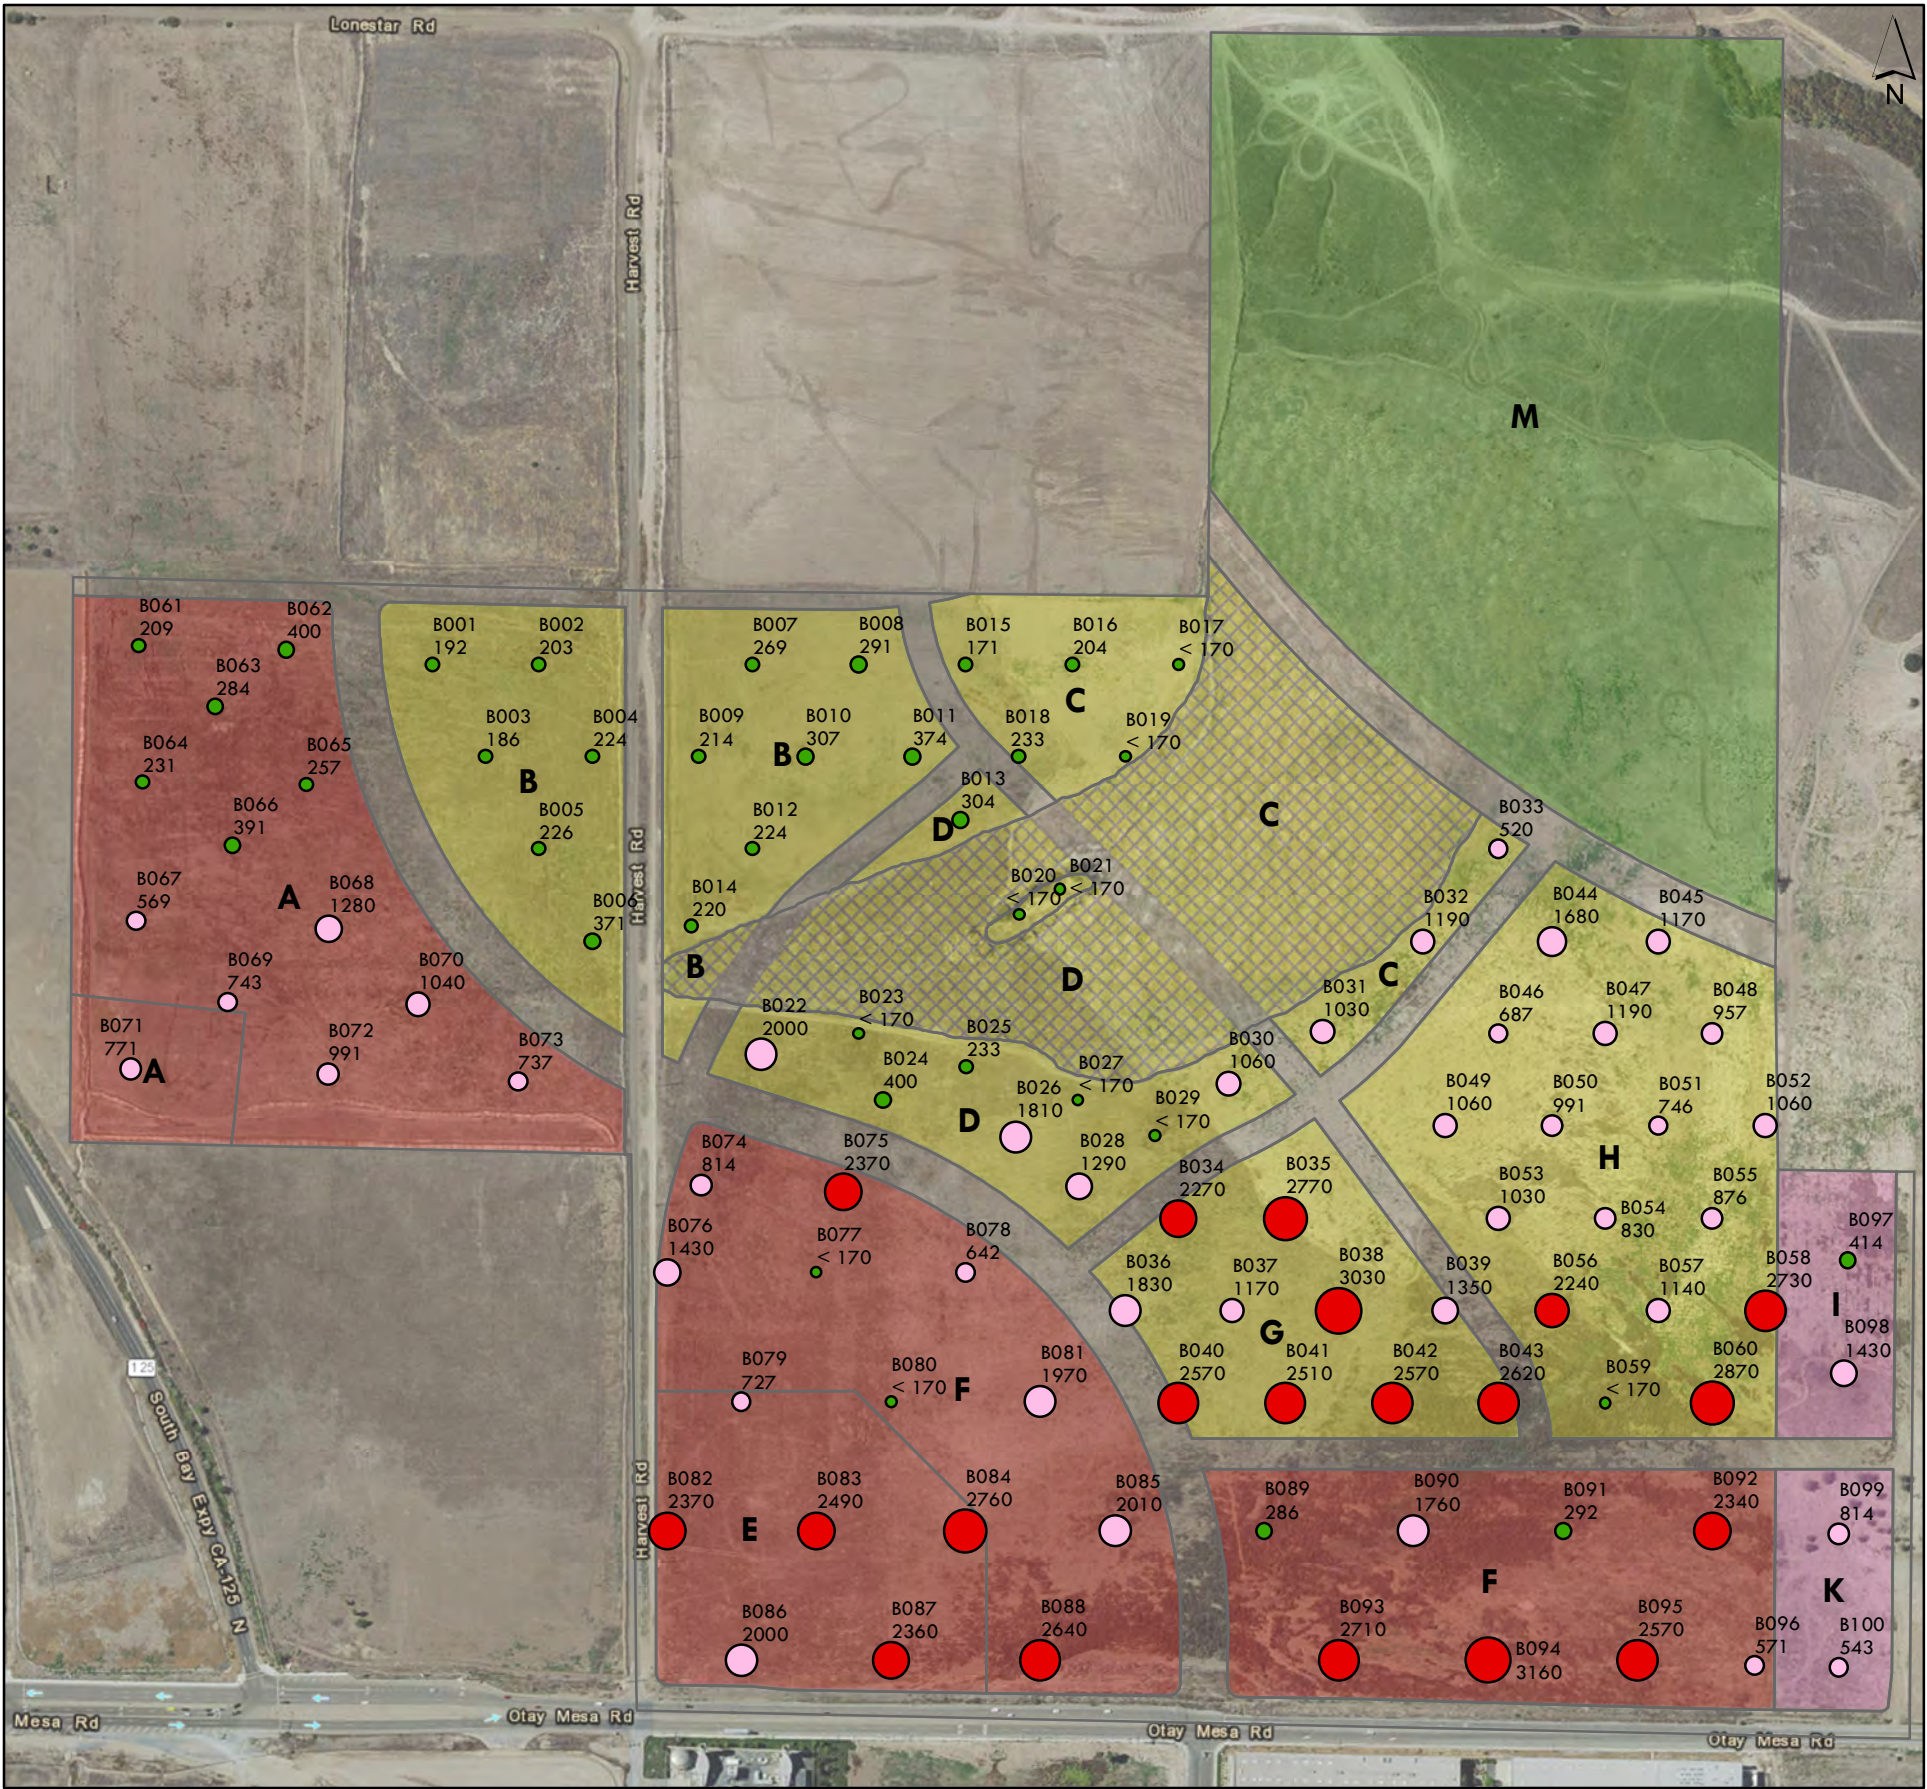
Toxaphene Concentrations (µg/kg)

Samples with Toxaphene above the Industrial RSL are depicted in red with samples above 2100 µg/kg

The analytical results from the samples analyzed indicate that toxaphene concentrations decrease with depth across the Site. An exception was observed in boring B074, which had its highest toxaphene concentration observed at 1.5 feet below grade at 1,330 µg/kg; however, the toxaphene concentration decreased at 3 feet below grade to below the laboratory reporting limit of 170 µg/kg.

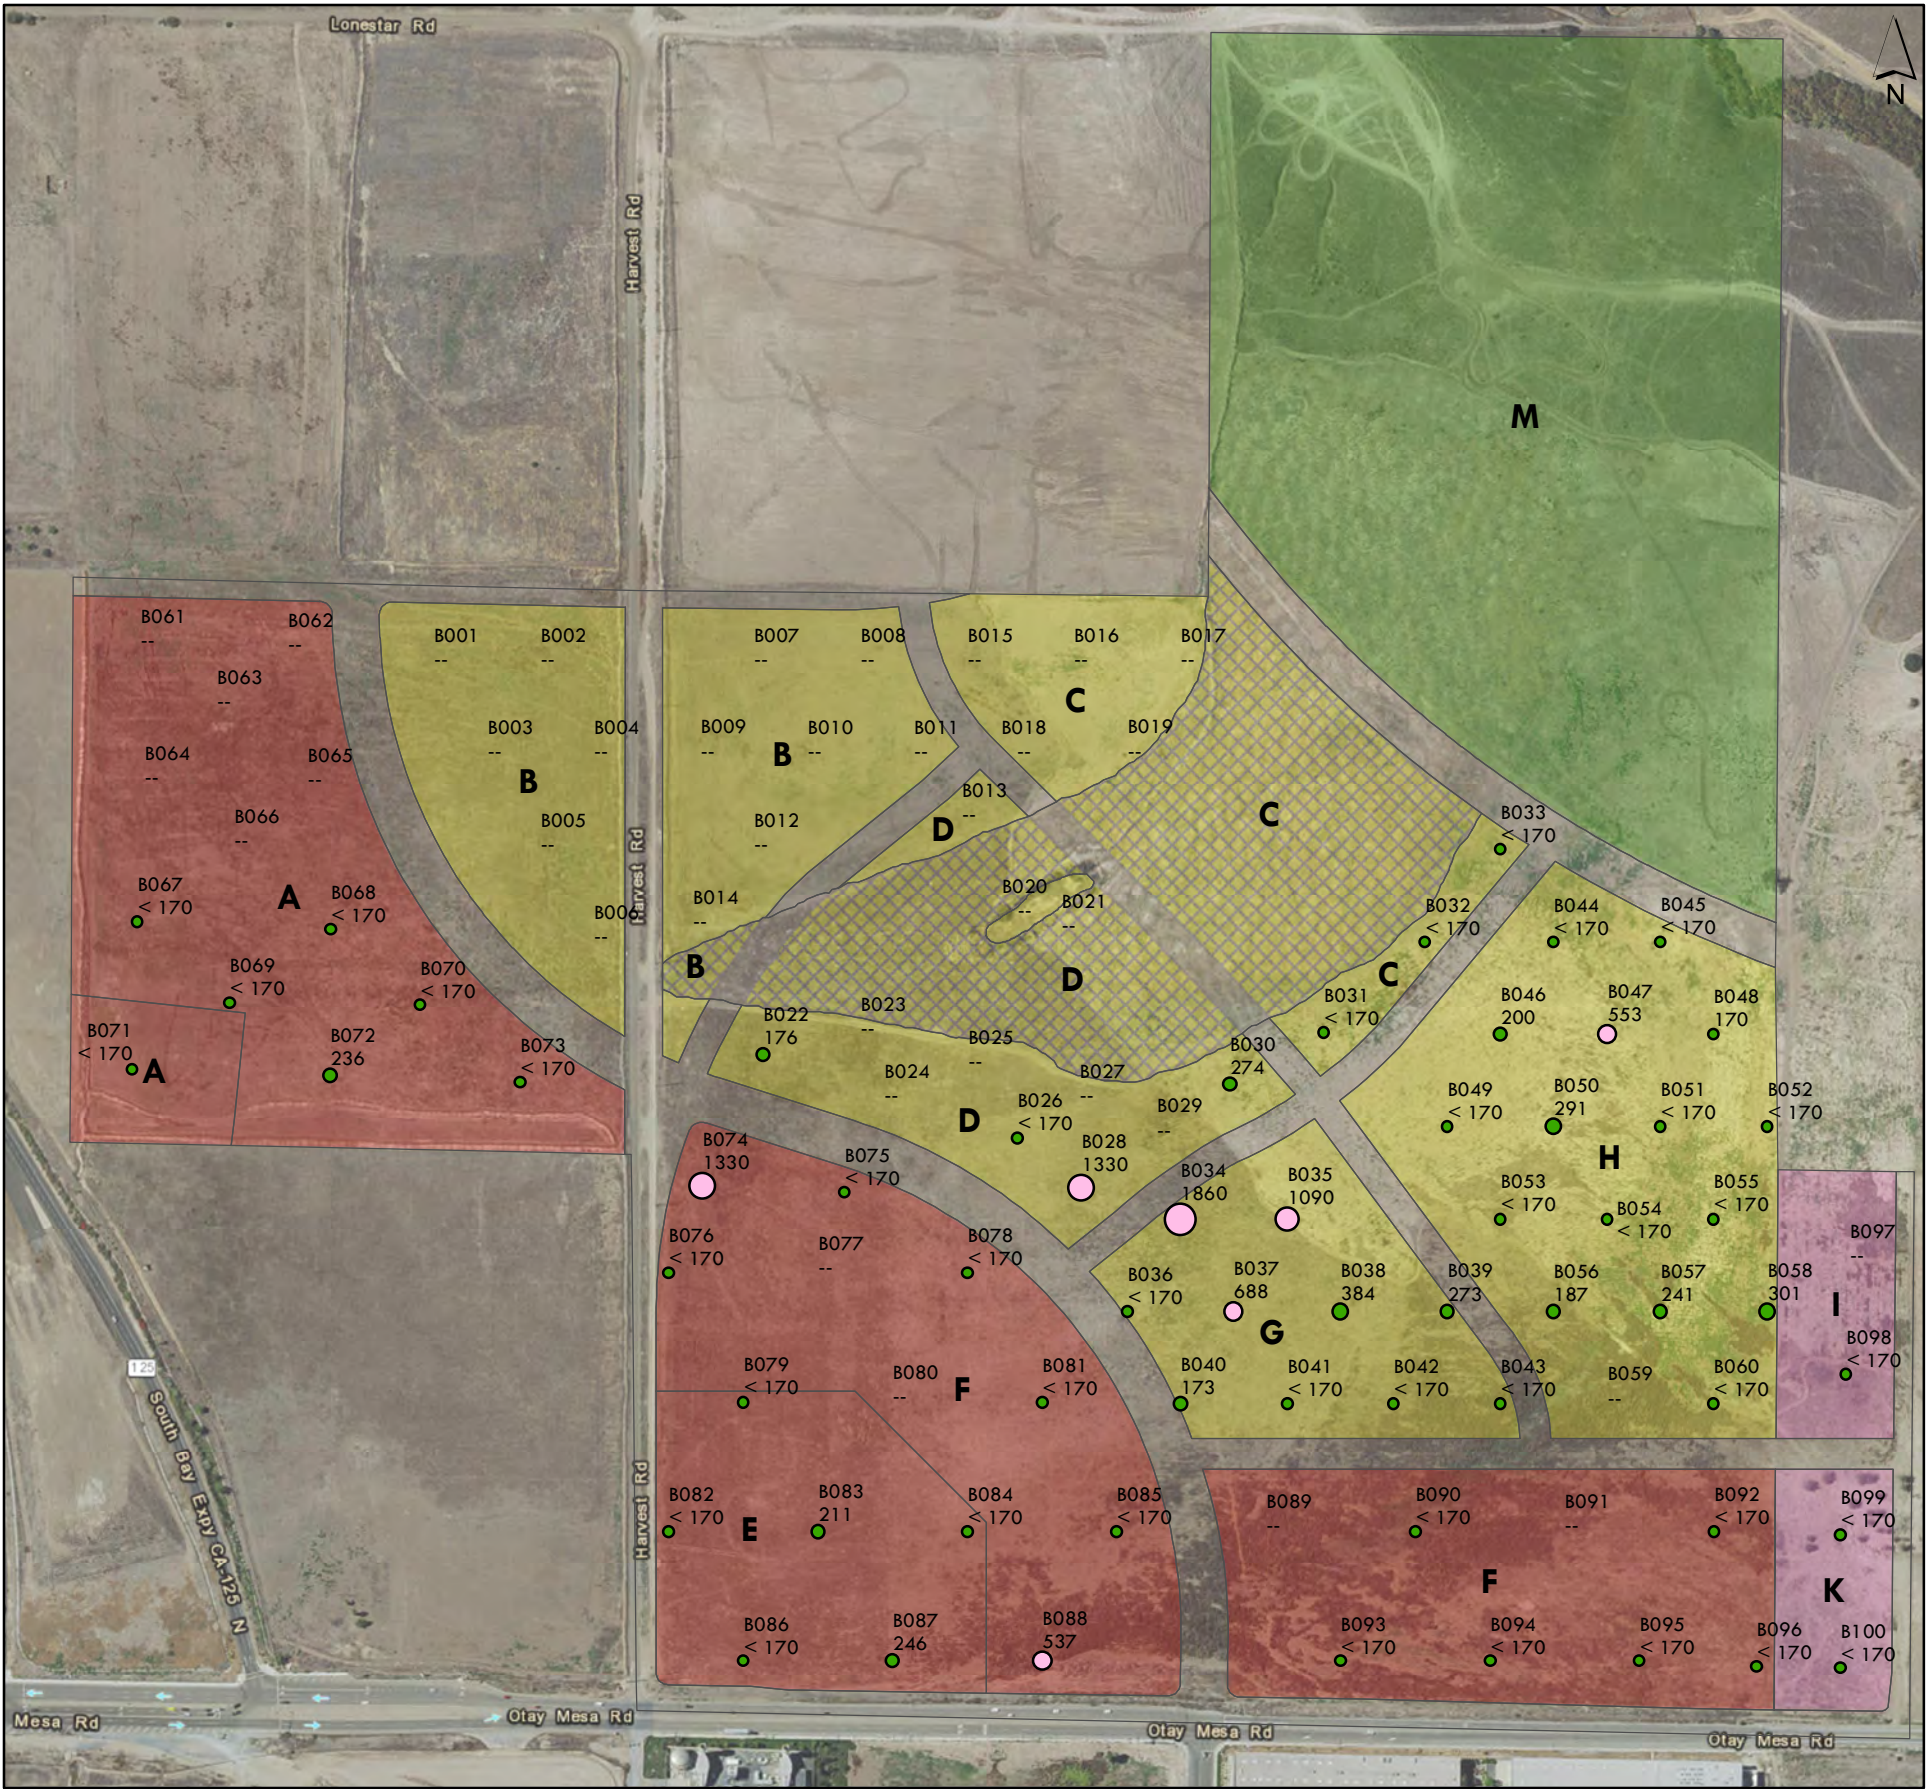
Toxaphene Concentrations (µg/kg)
