## Topographic Cross Sections

HARMONY GROVE VILLAGE SOUTH

## Slopes Providing the Project Setting

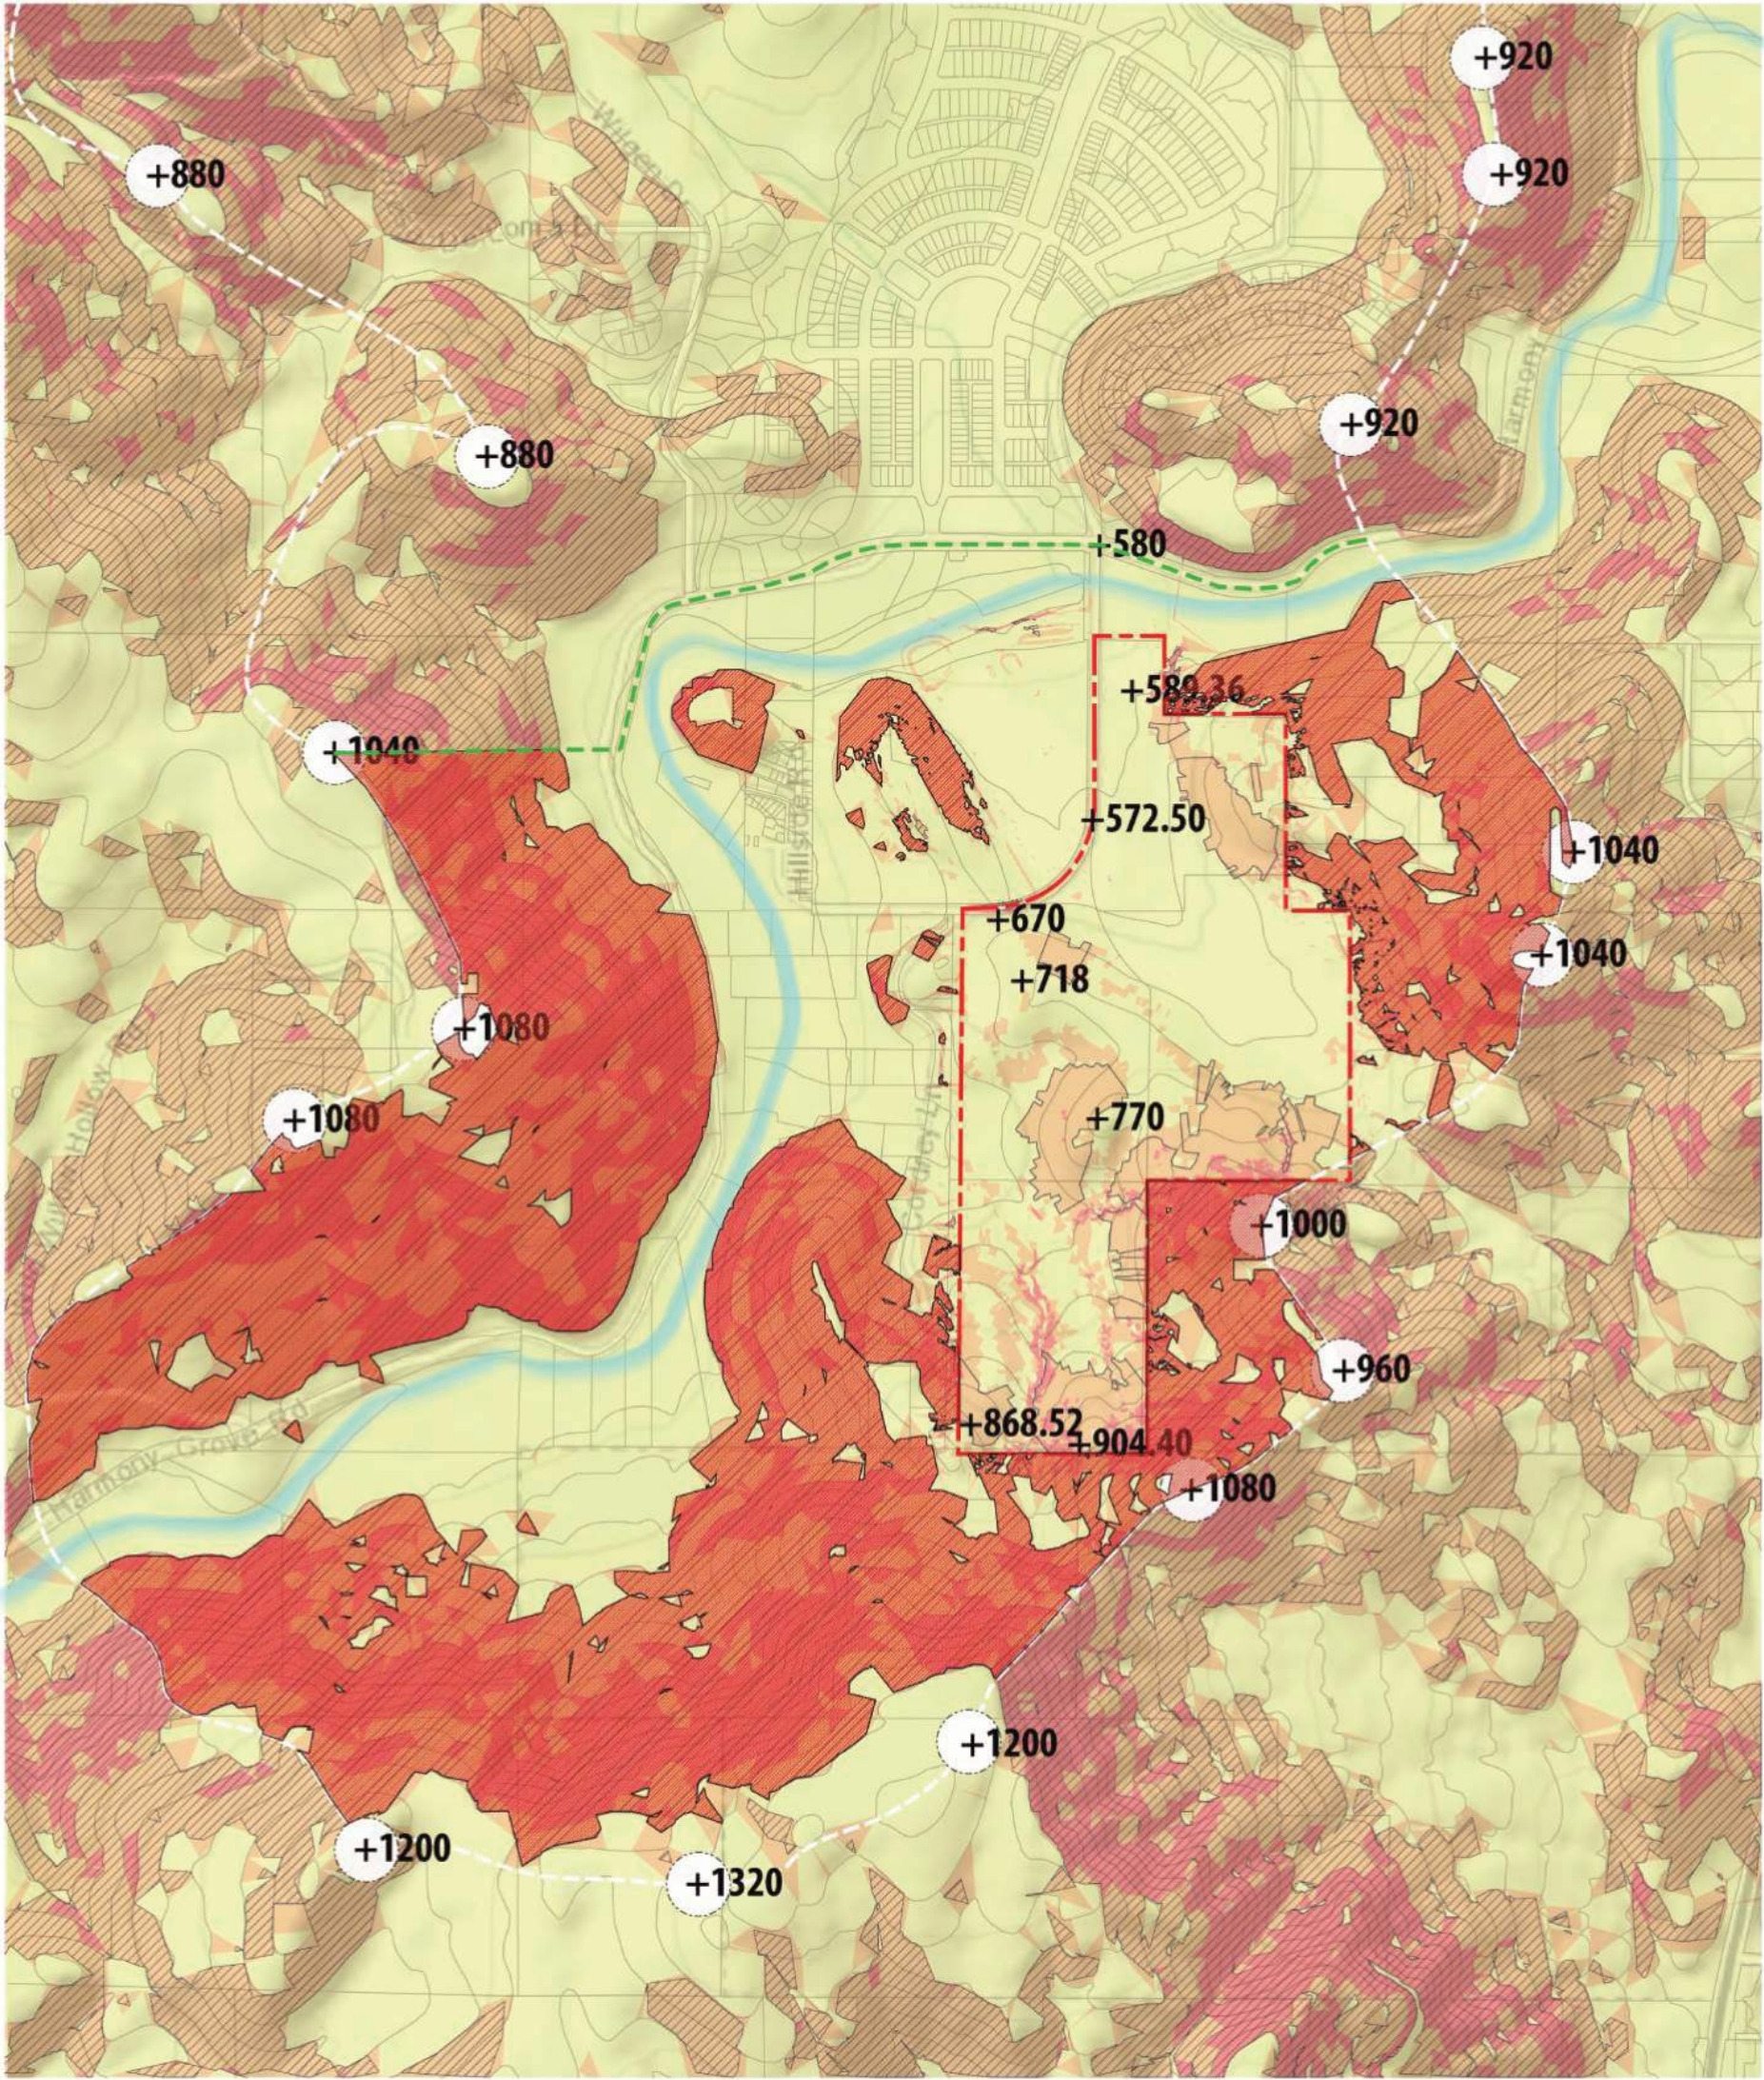
- Site Boundary
- Knoll and Ridge Line
- 0 - 25%
- 25% - 50%
- 50% - Above
- Above 25%, 50 Feet or More in Height Within Site Boundary
- Above 25%, 50 Feet or More in Height Outside Site Boundary
- Steep slopes within ridgeline south of Harmony Grove Road

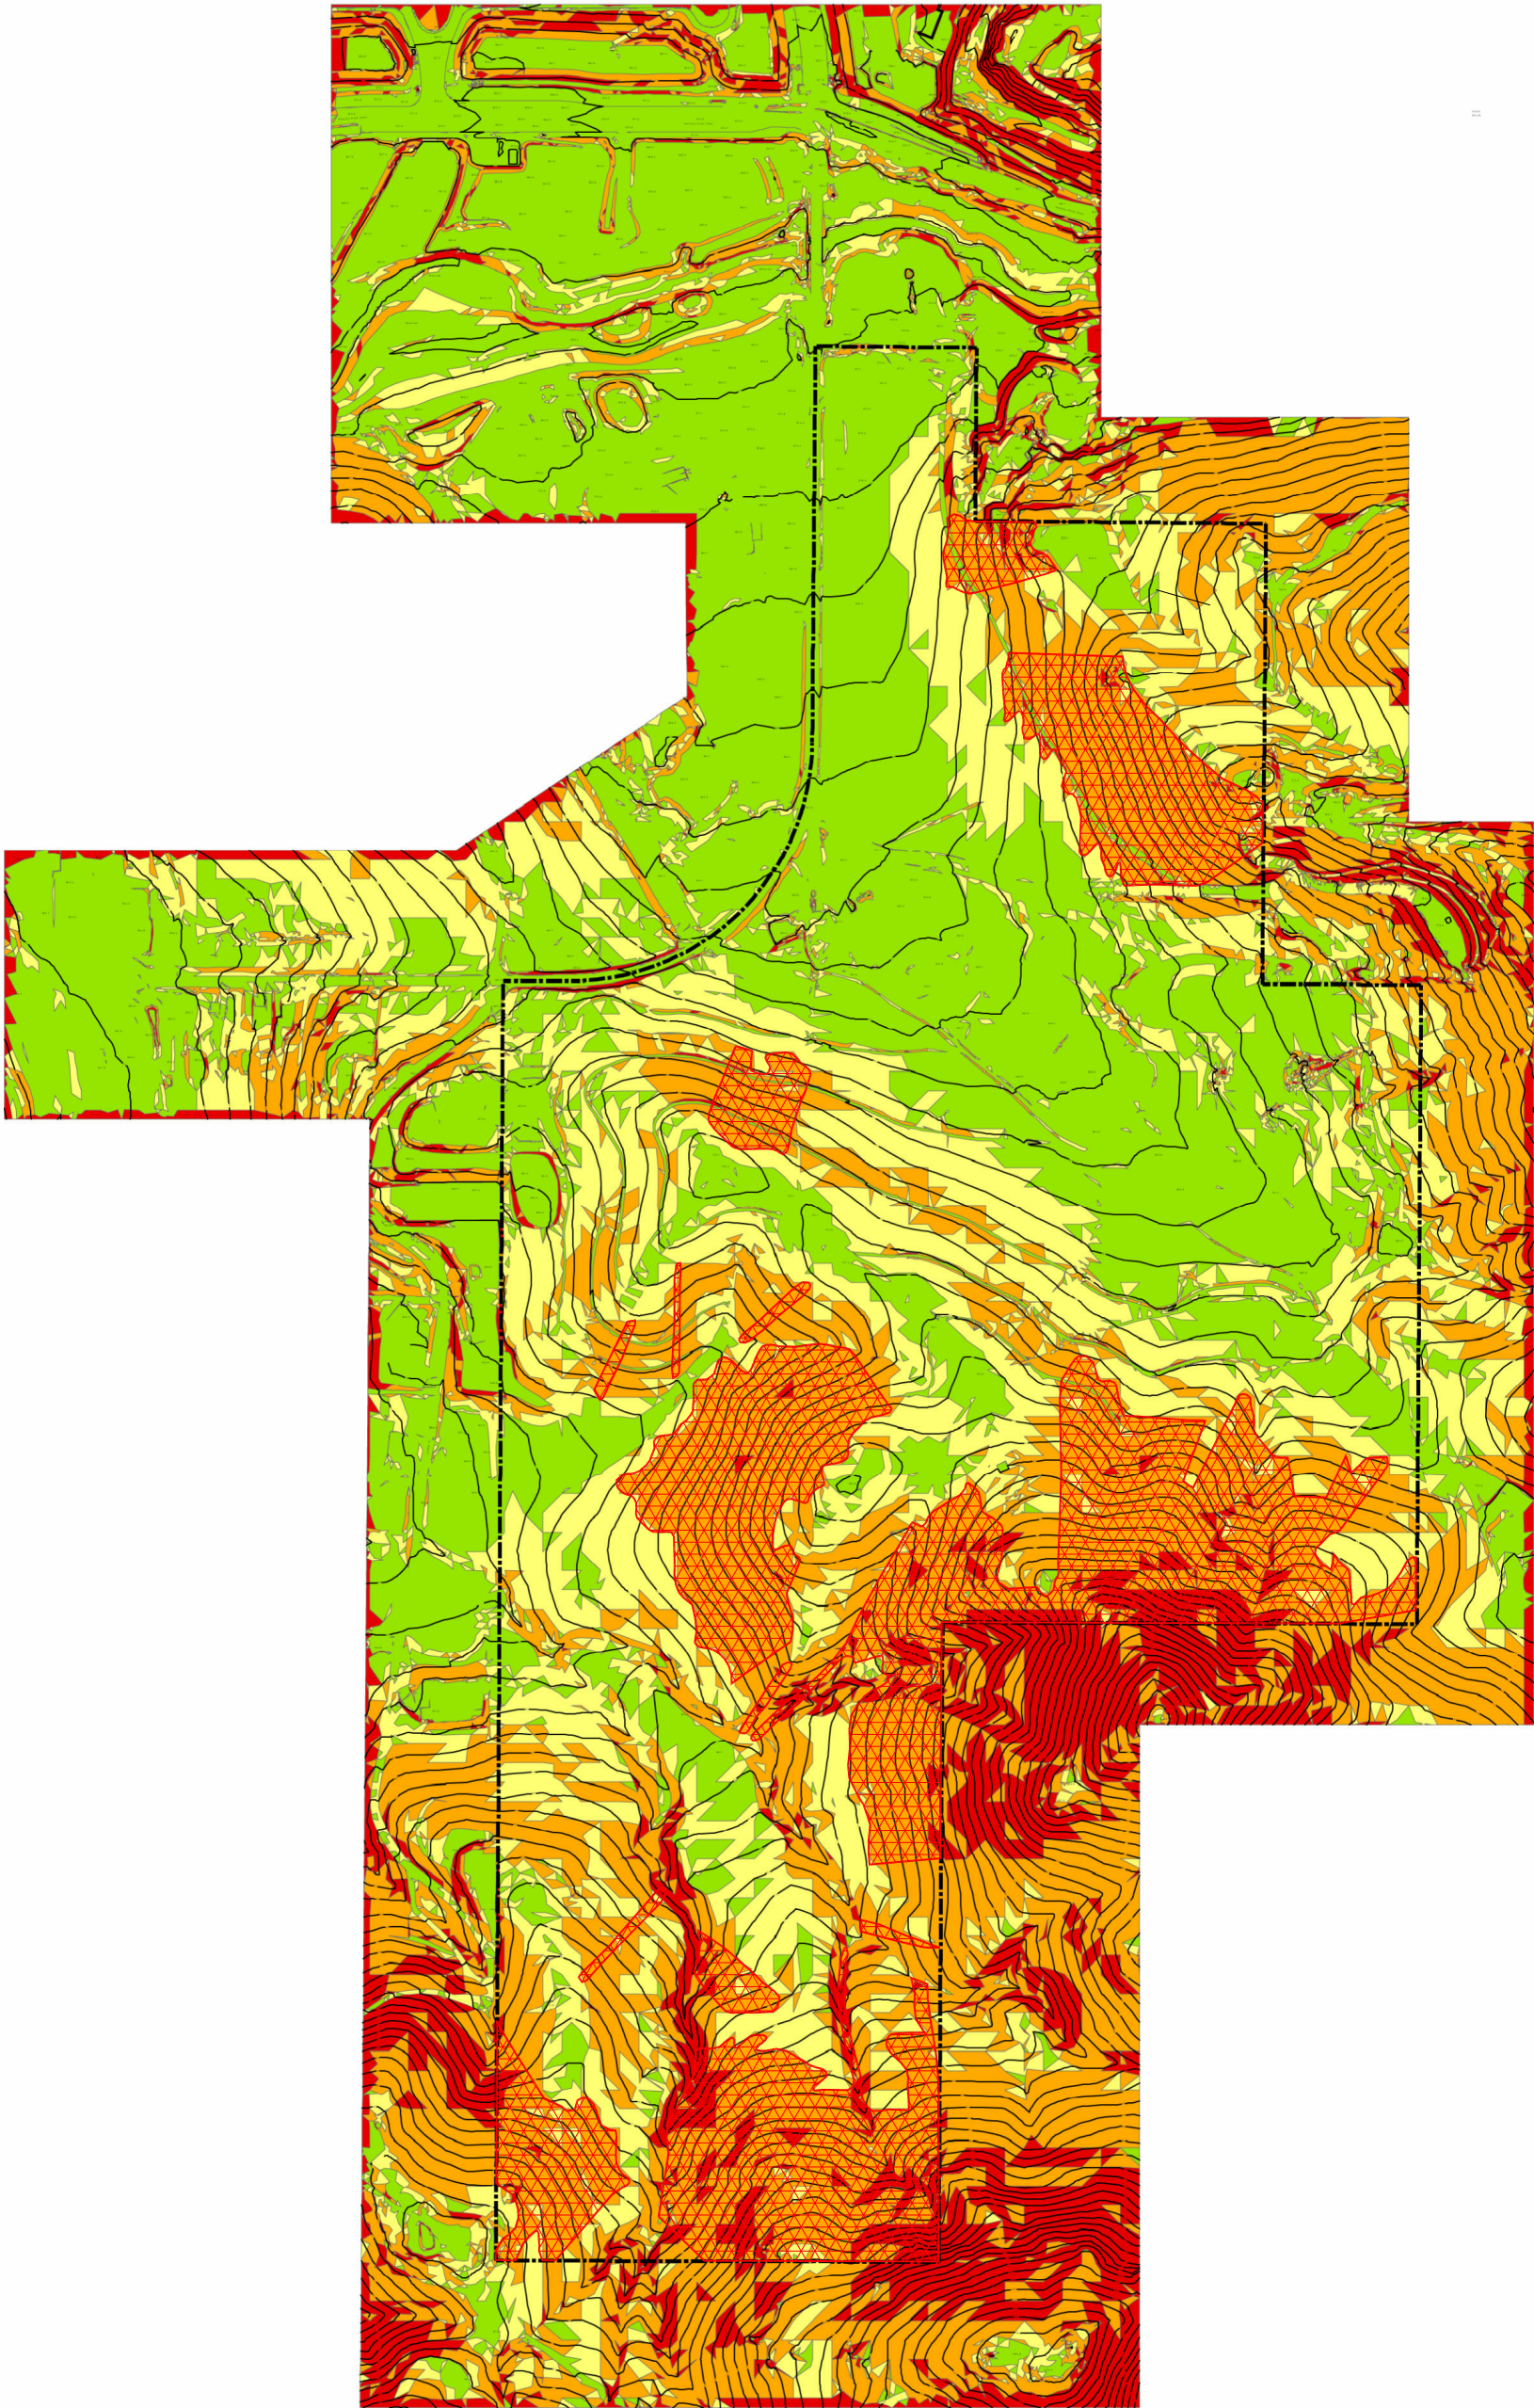
| SLOPE TABLE | | | | LEGEND | |
|---|---|---|---|---|---|
| Semi-Rural 0.5 | Acreage | Density | Allowable Dwelling Units | | LESS THAN 15% |
| Slope less than 25% | 66.7 | 2 dwelling units per acre | 133 | | 15% AND GREATER UP TO 25% |
| Slope 25% to less than 50% | 39.7 | 1 dwelling unit per acre | 39 | | 25% AND GREATER UP TO 50% |
| Slope 50% or greater | 4.6 | 1 dwelling unit per 2 acres | 2 | | 50% AND GREATER |
| Total | 111 | | 174 | | RPO DEFINED STEEP SLOPES |

Study Area Slope Map  
HARMONY GROVE VILLAGE SOUTH

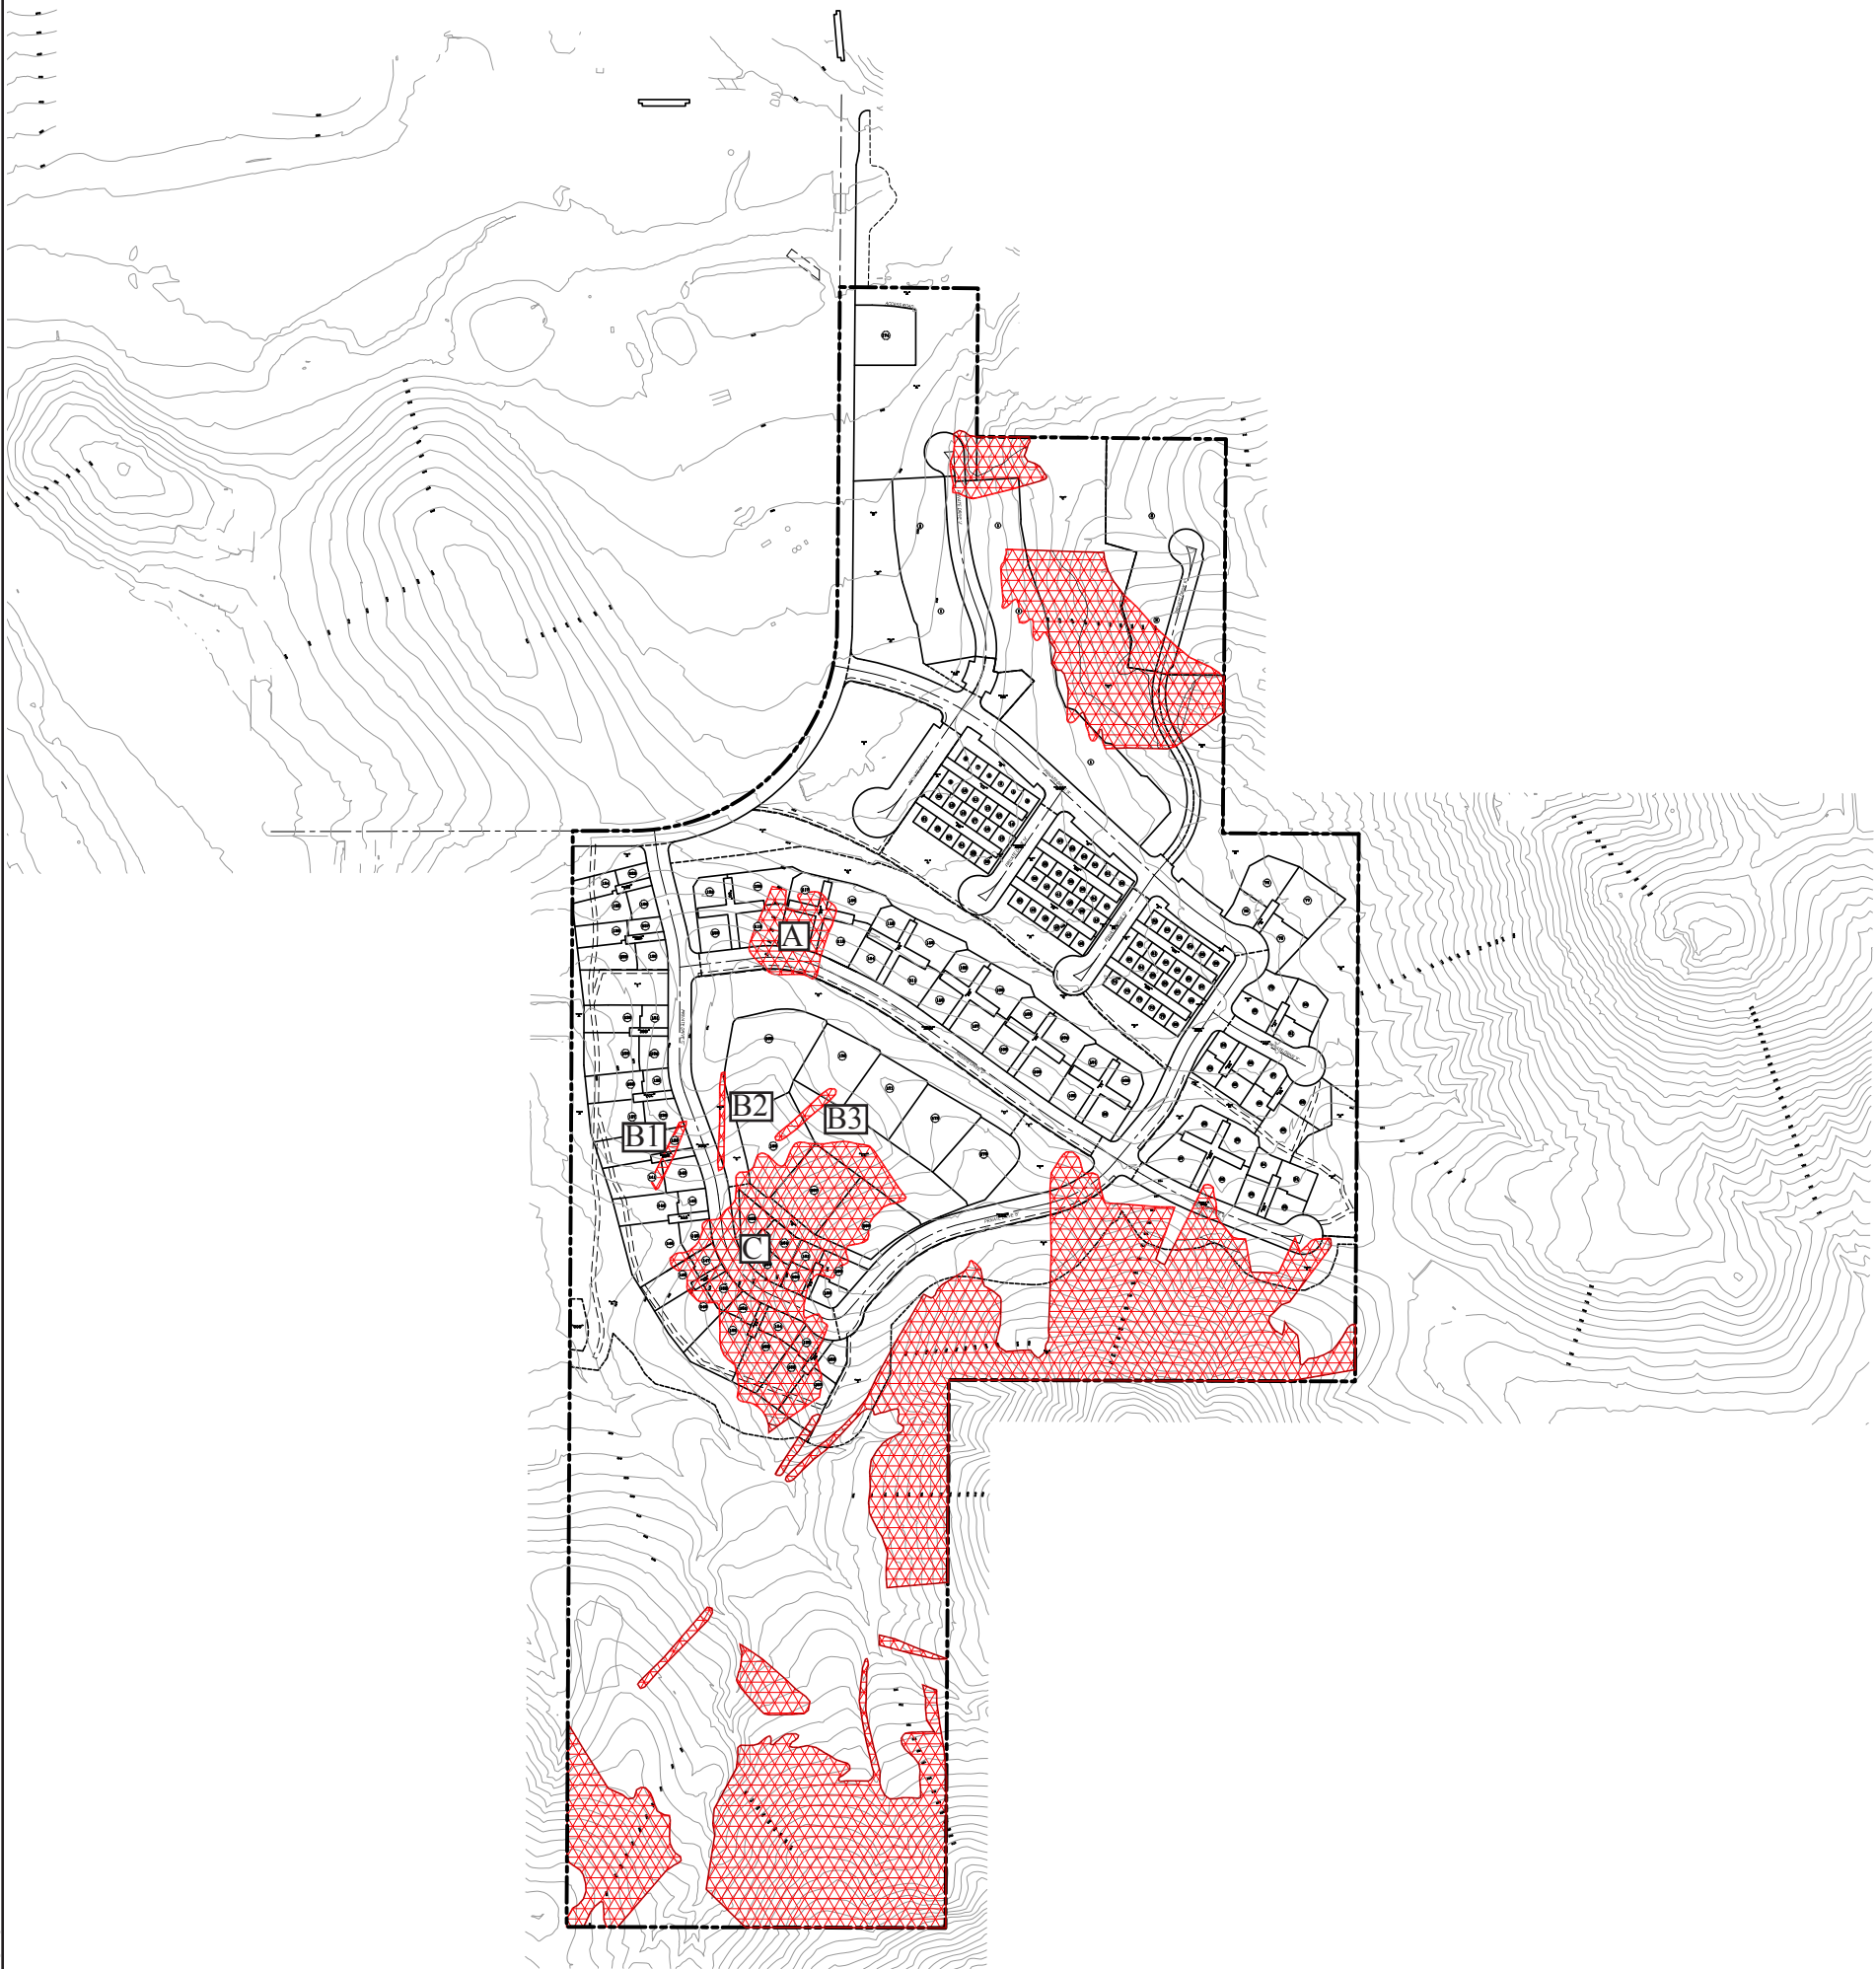
# RPO Steep Slopes

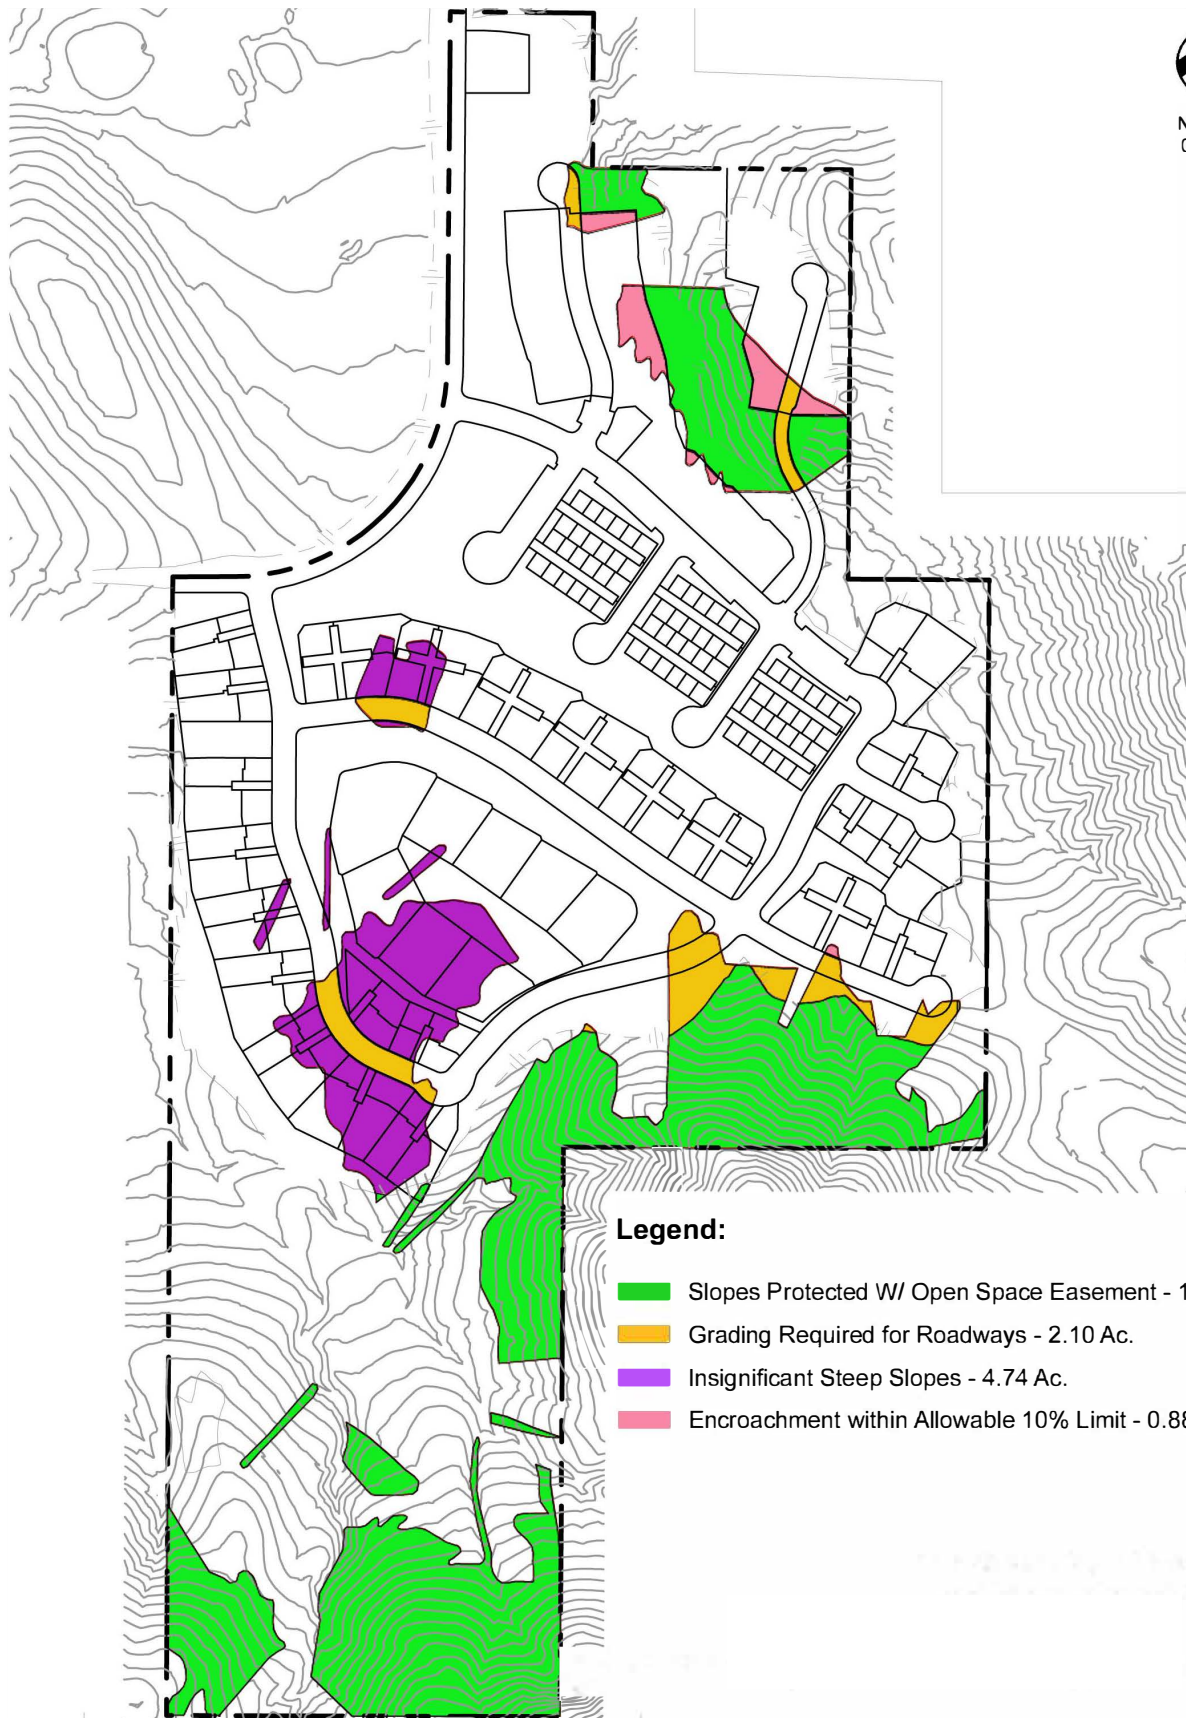
## RPO Steep Slope Preserve and Encroachment Areas
