Groundwater Resources Investigation Report Tierra del Sol Solar Farm Project

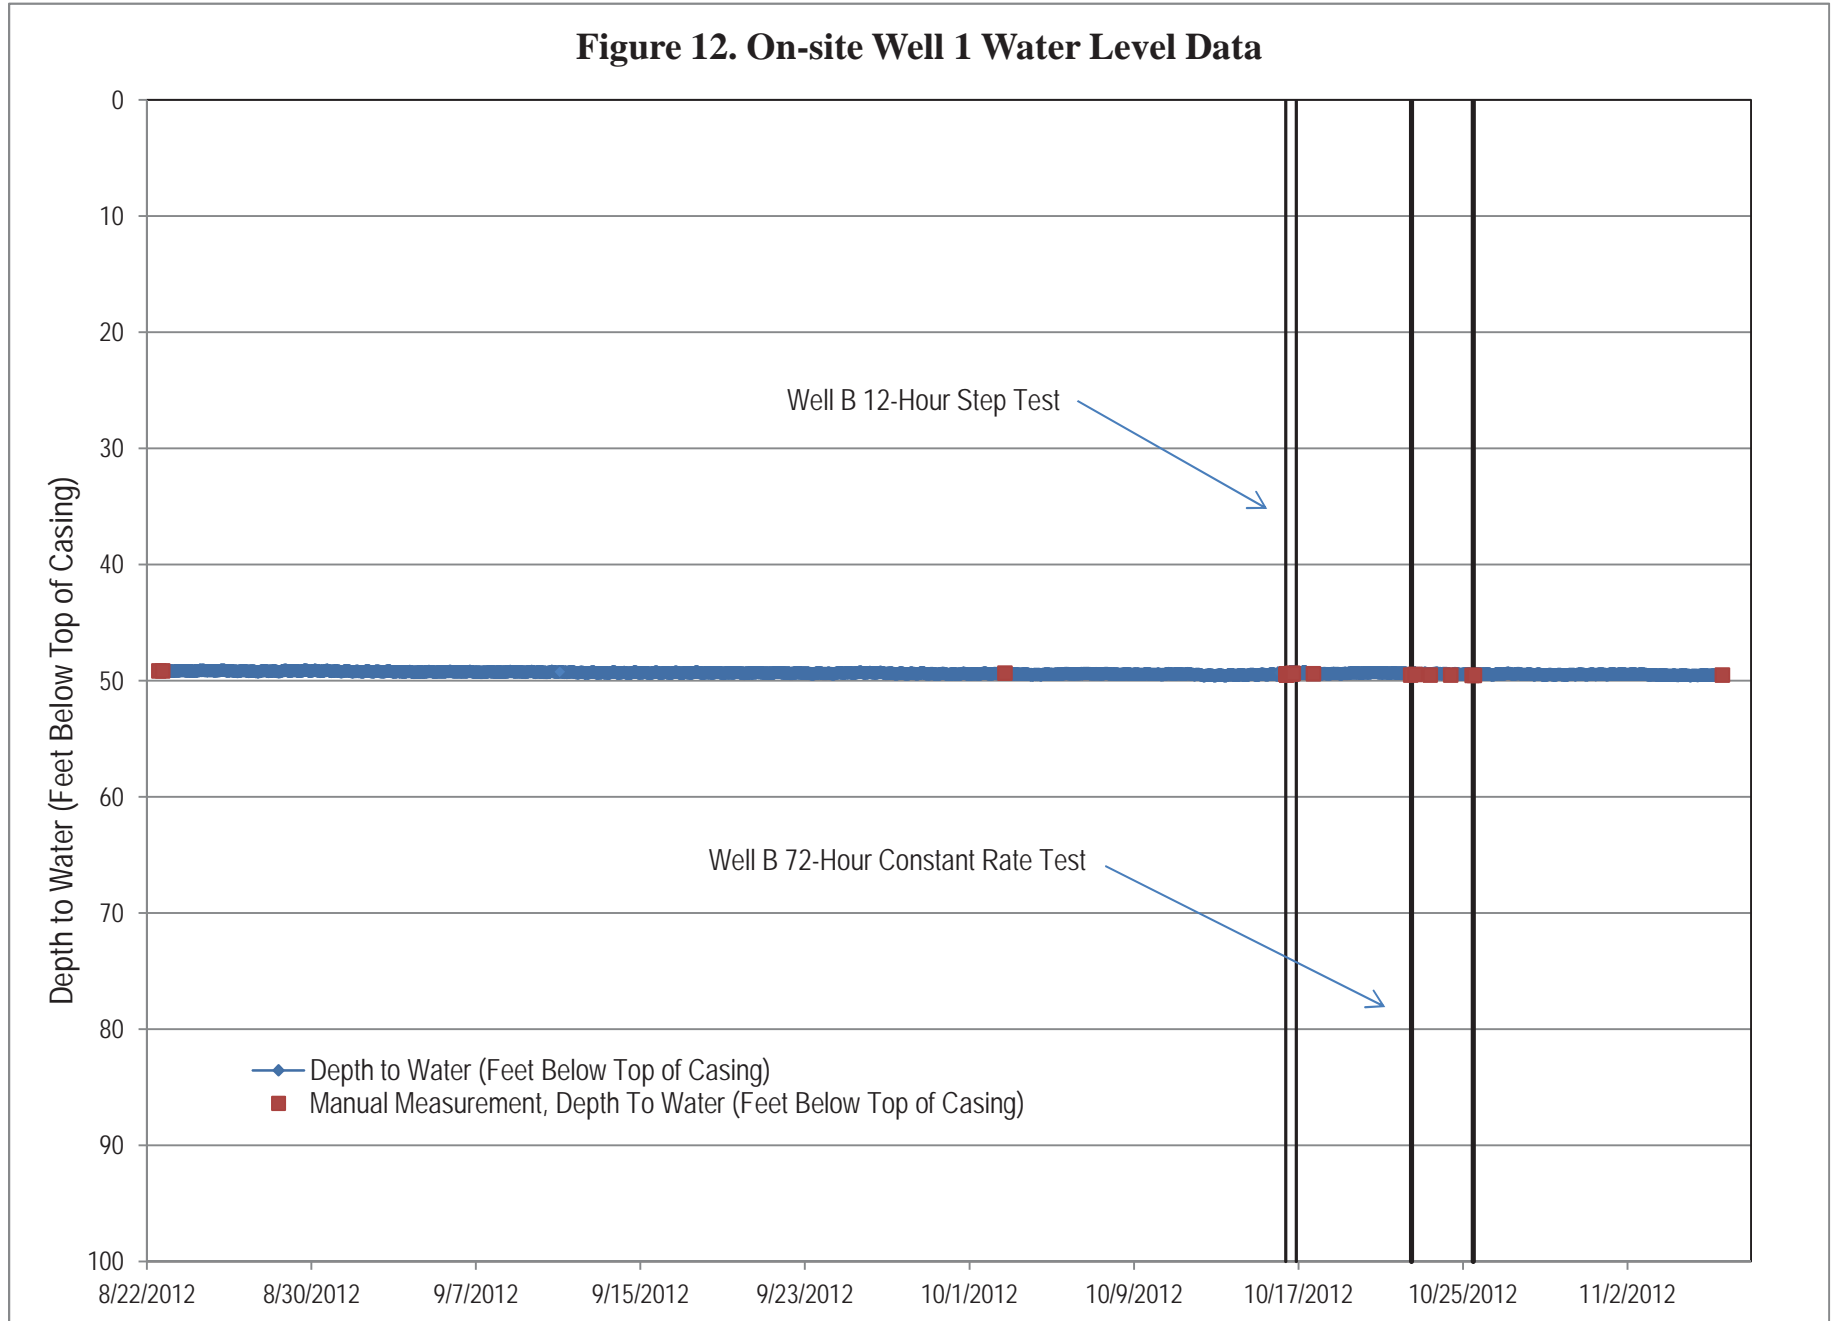
Figure 12. On-site Well 1 Water Level Data

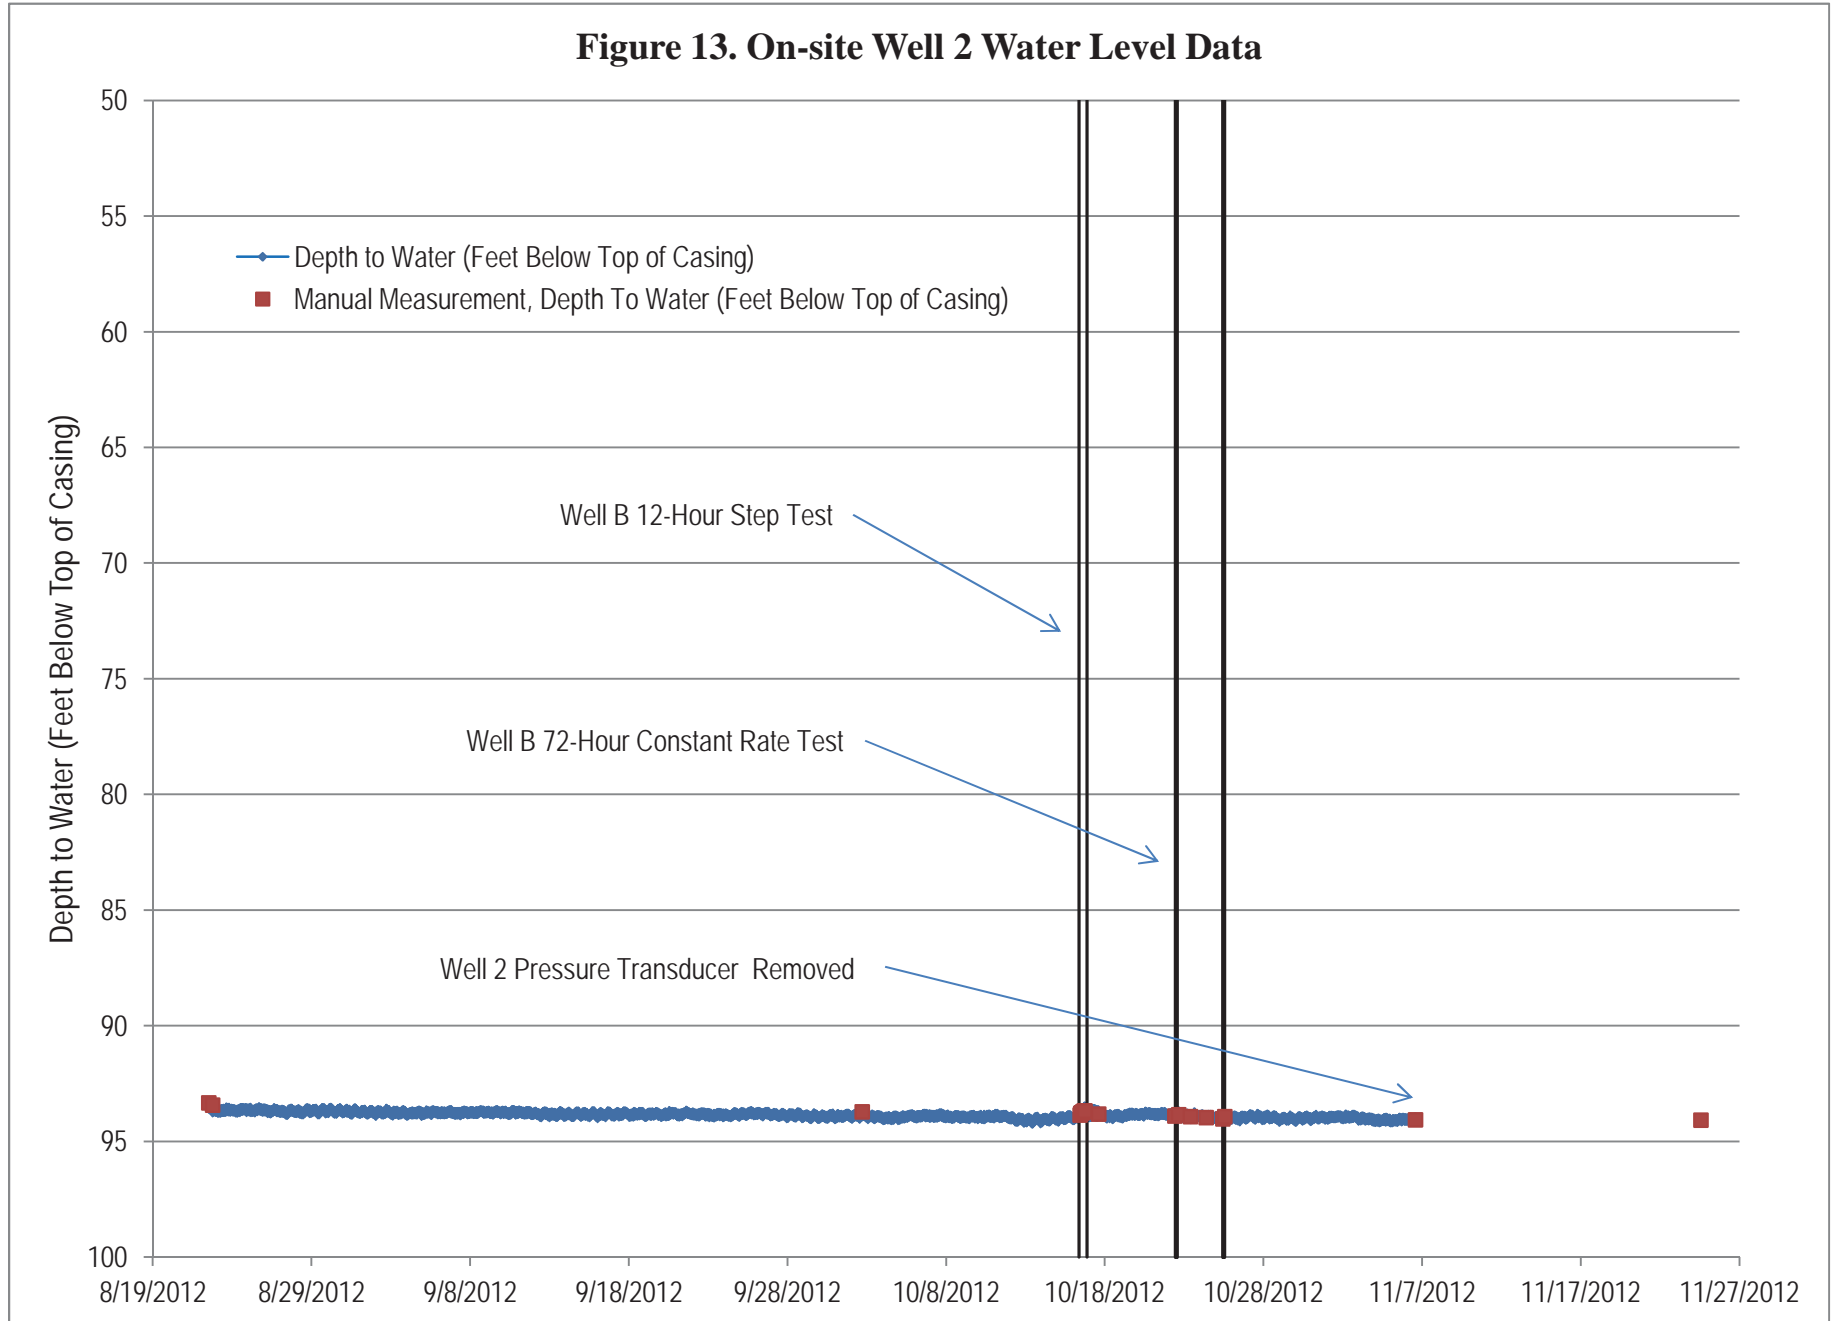
Figure 13. On-site Well 2 Water Level Data

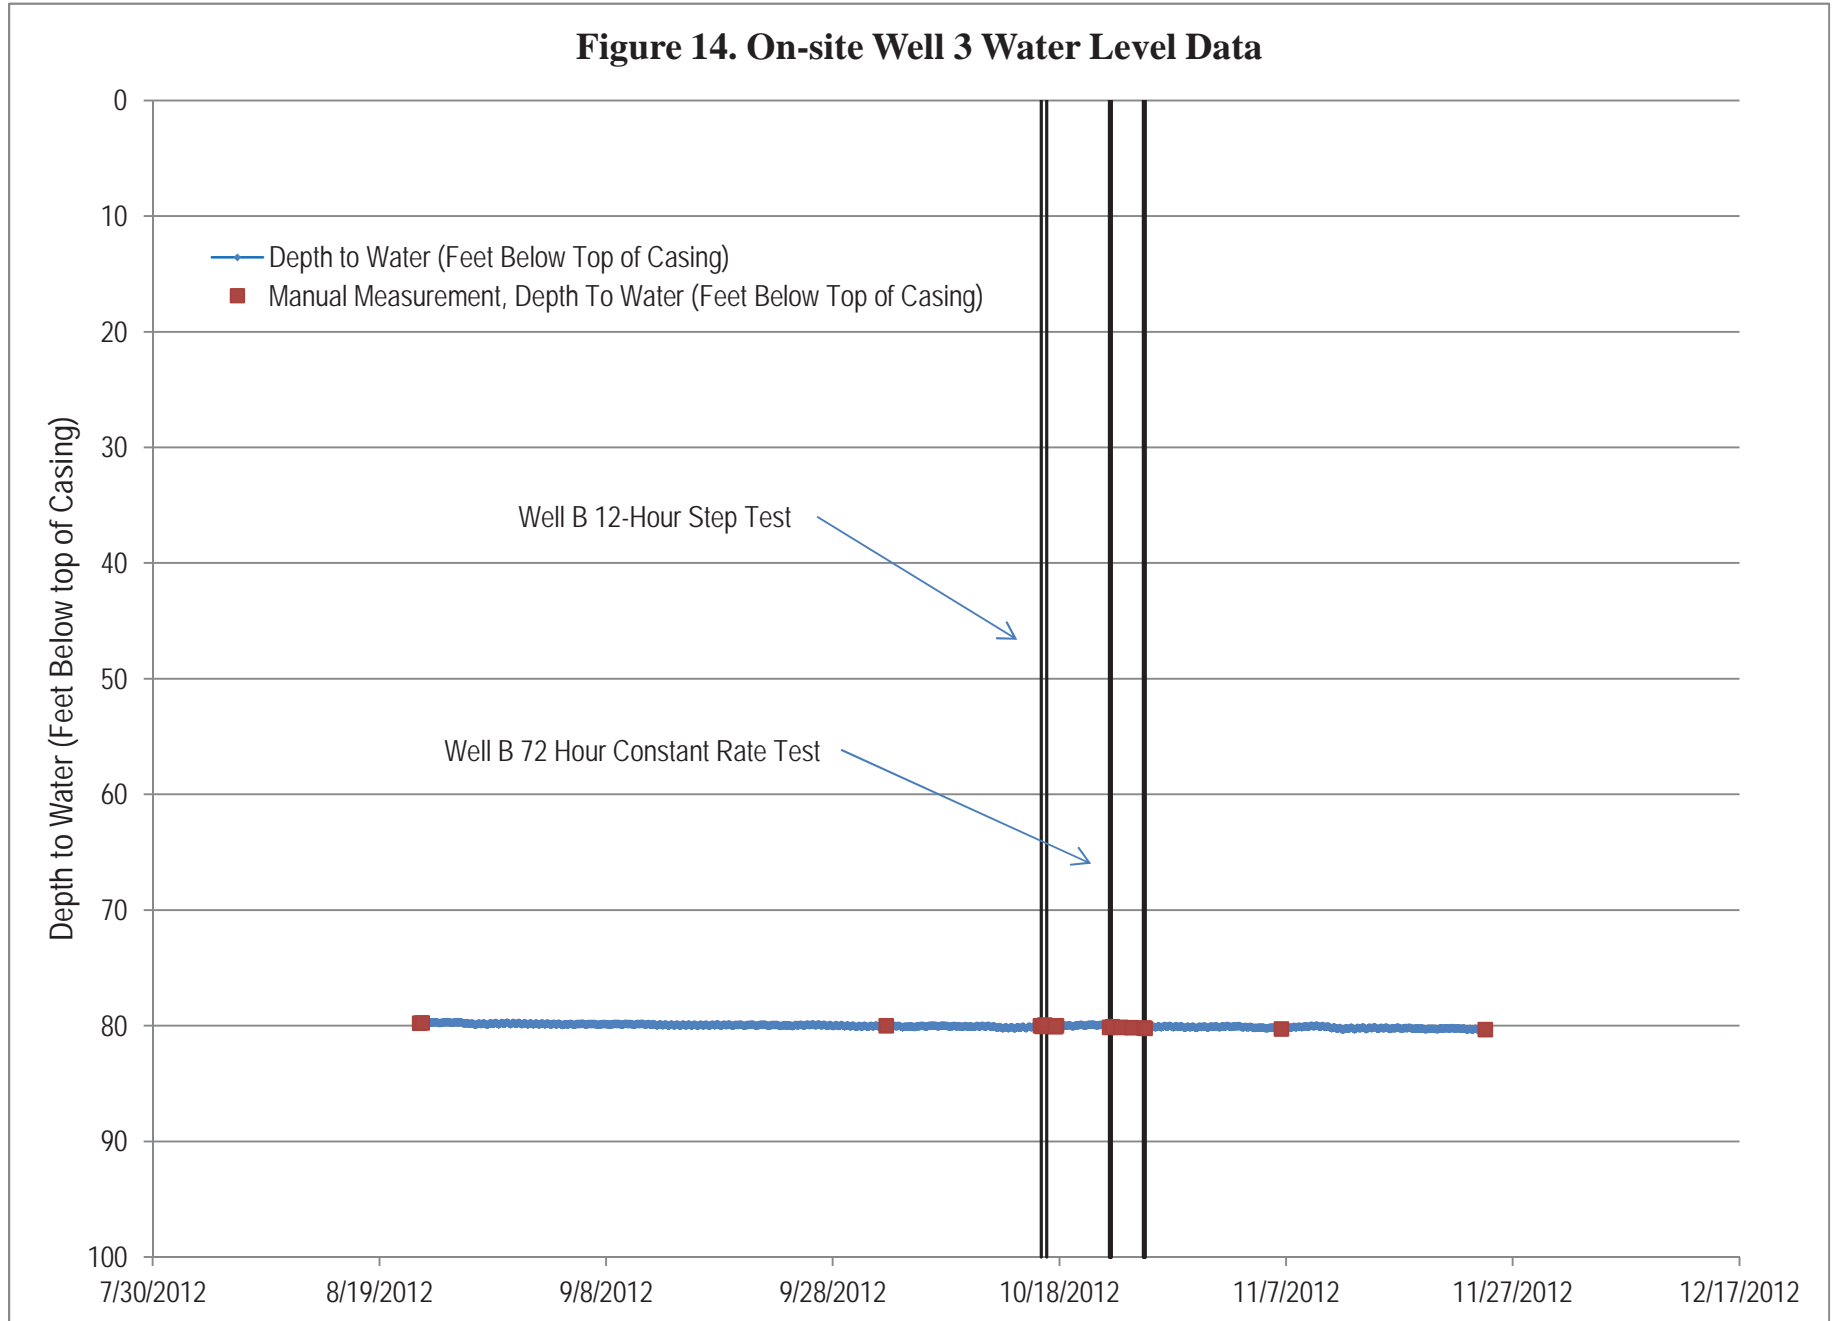
Figure 14. On-site Well 3 Water Level Data

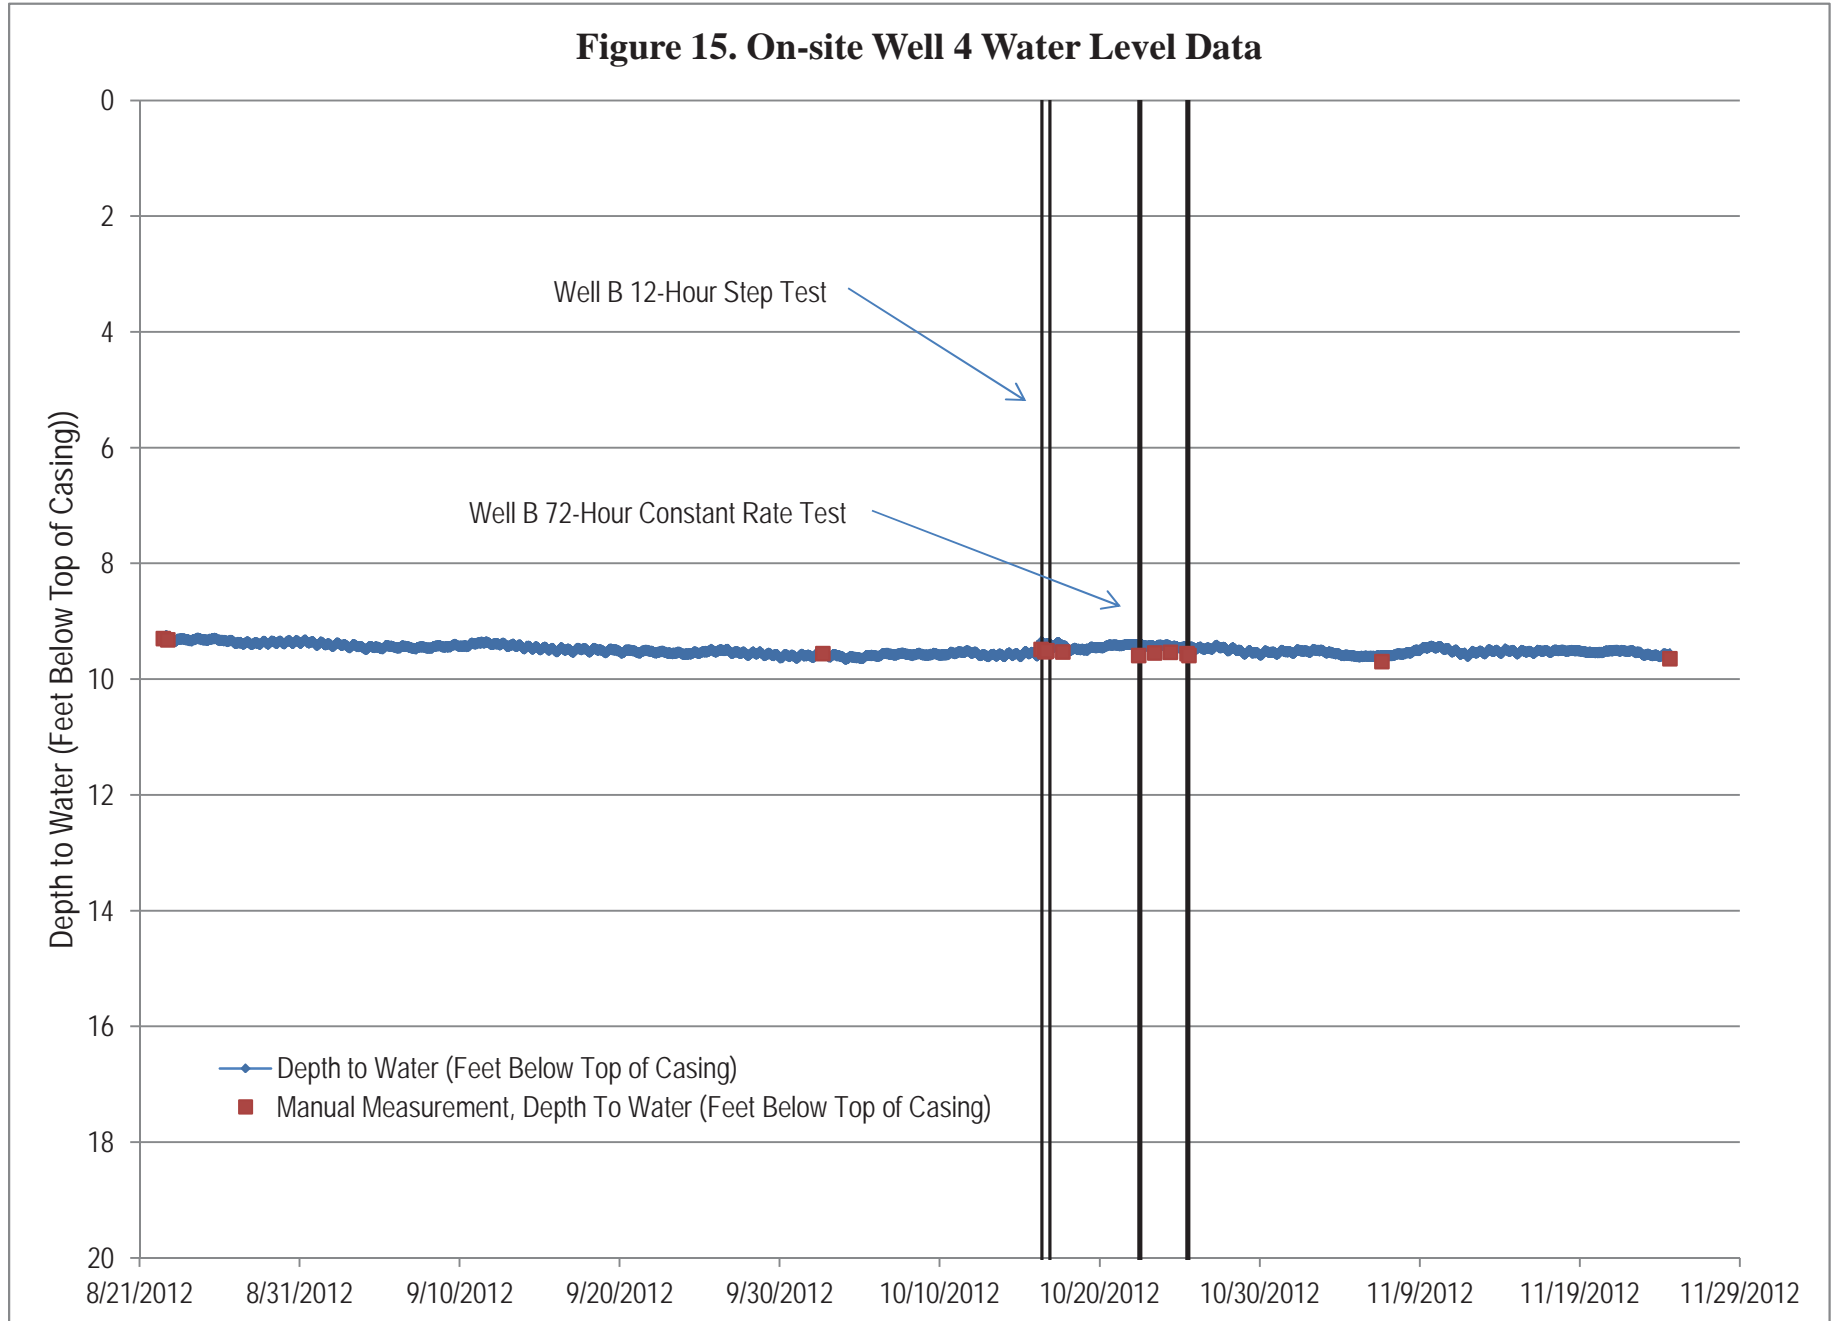
Figure 15. On-site Well 4 Water Level Data

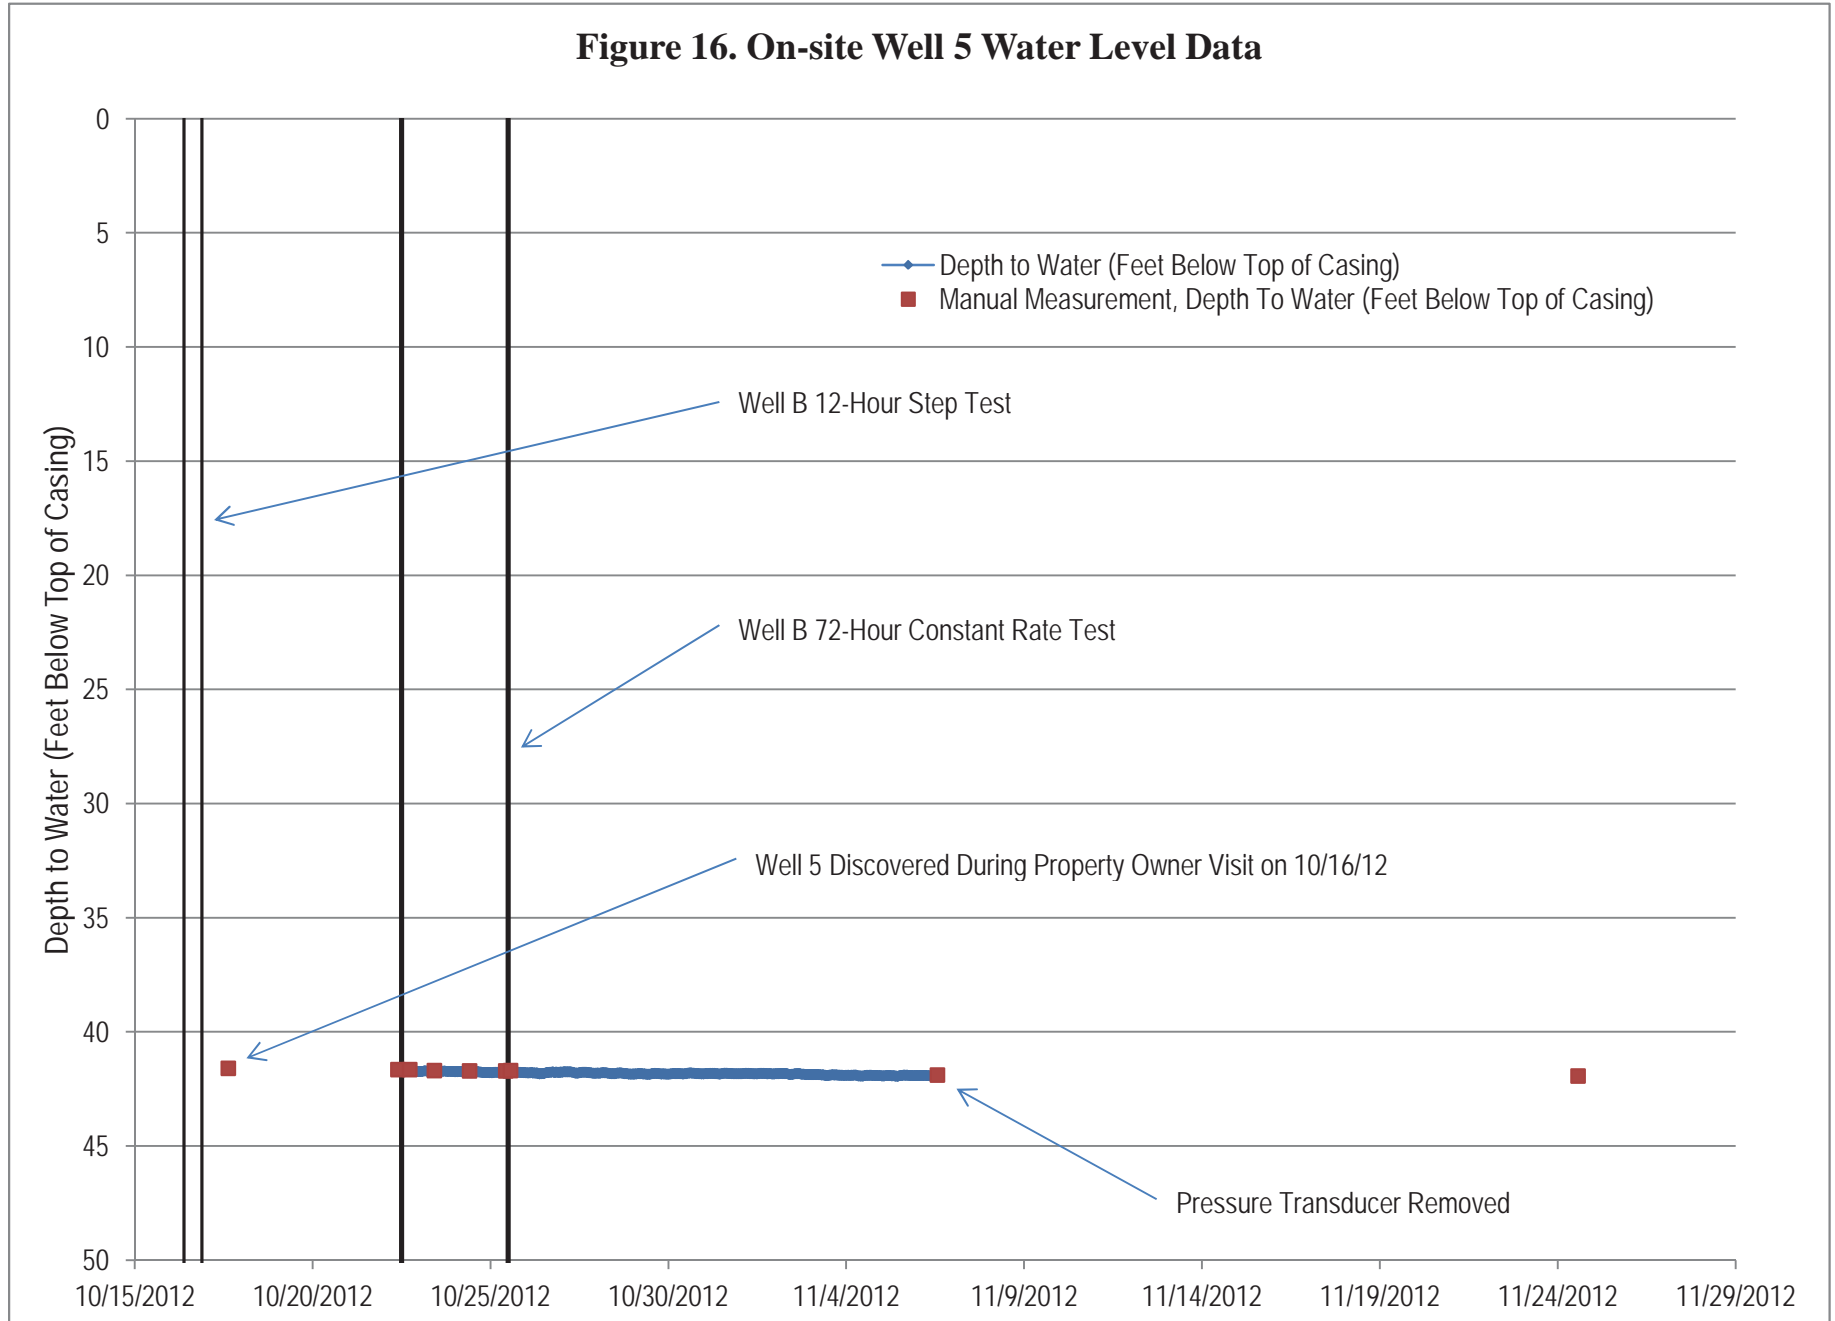
Figure 16. On-site Well 5 Water Level Data
