**EDGEMOOR GERIATRIC HOSPITAL  
ADAPTIVE RE-USE STUDY**

**Magnolia Avenue  
Santee, California**

**Prepared for the  
County of San Diego, California**

**June 1<sup>st</sup>, 2008**

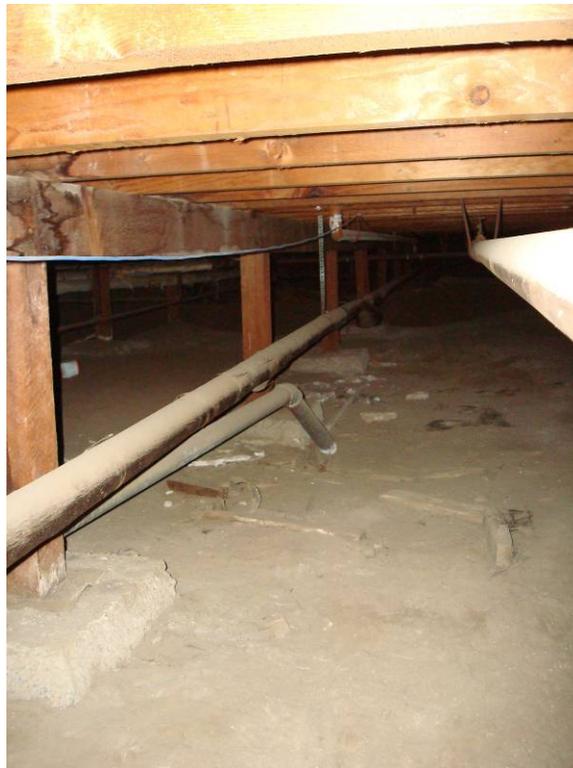
*Figure 4. Raised Floor in Building 2.*

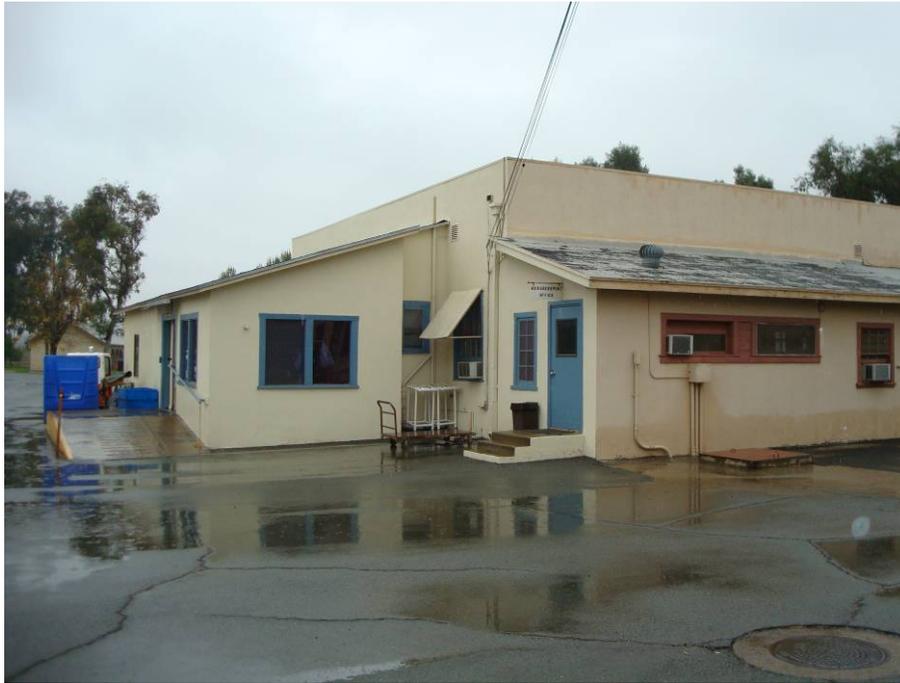
*Figure 9. Additions to Building 3.*

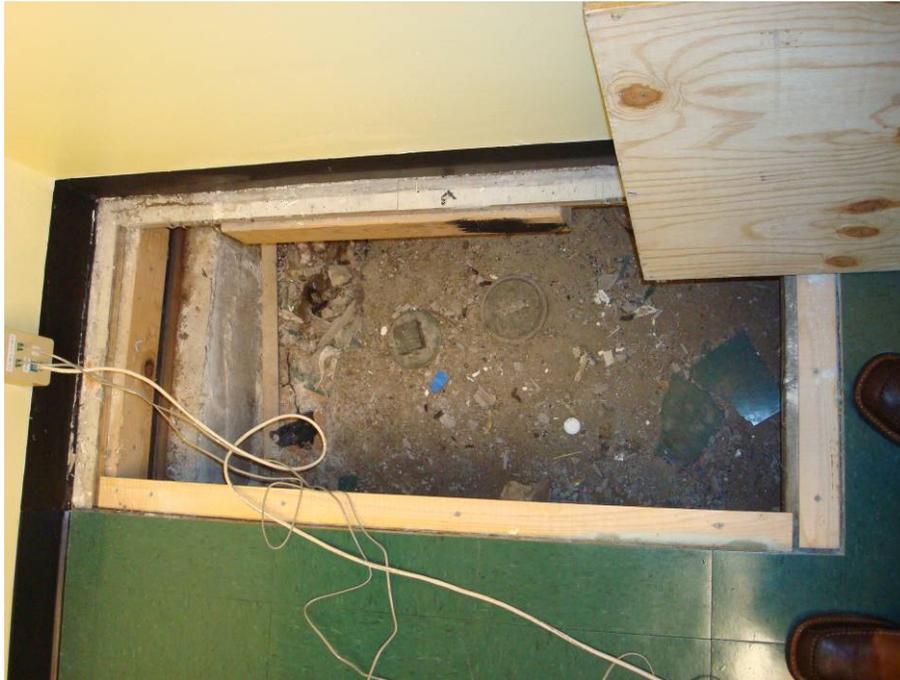
*Figure 10. Raised floor in Building 3*

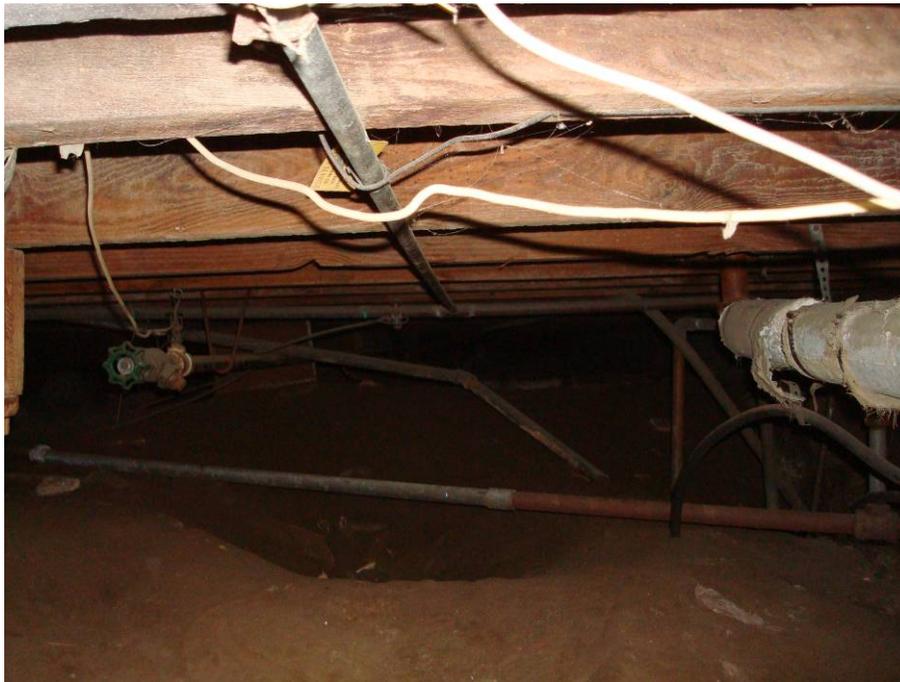
*Figure 12. Raised wood floor of Building 3.*

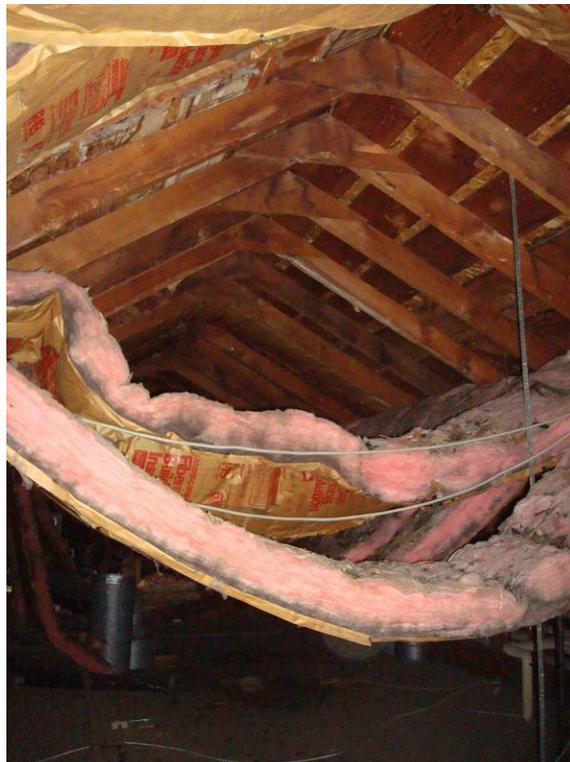
*Figure 18. Attic framing members with signs of water intrusion in Building 8.*

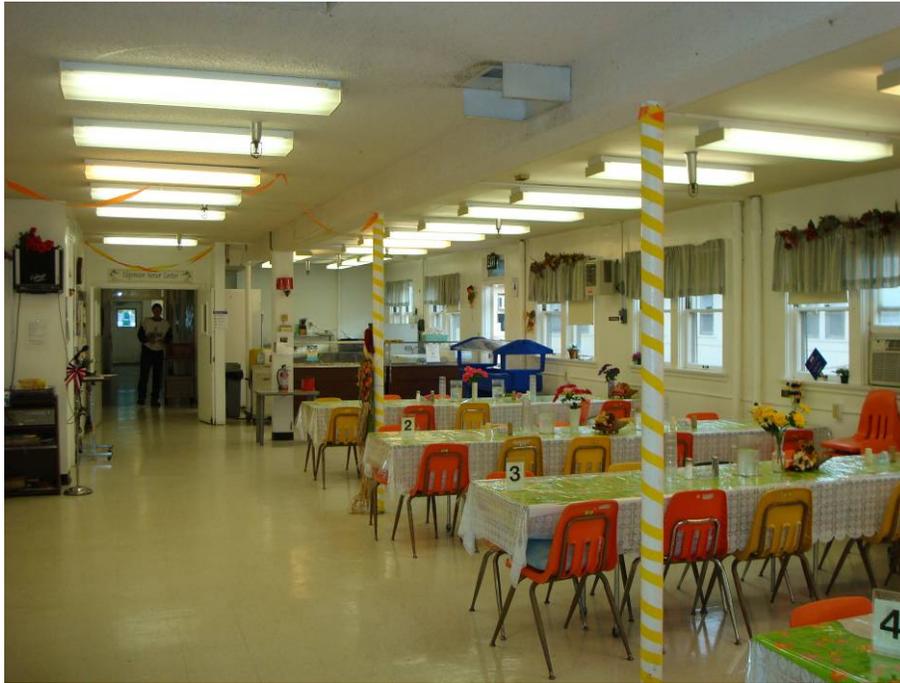
Figure 19. Interior of Building 8 with steel pipe columns supporting the attic framing.

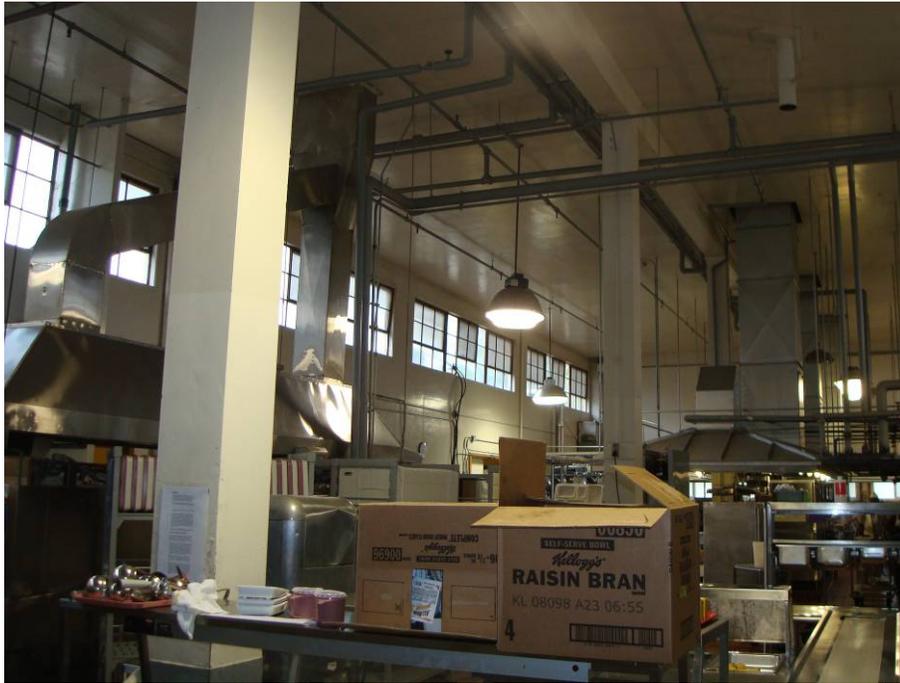
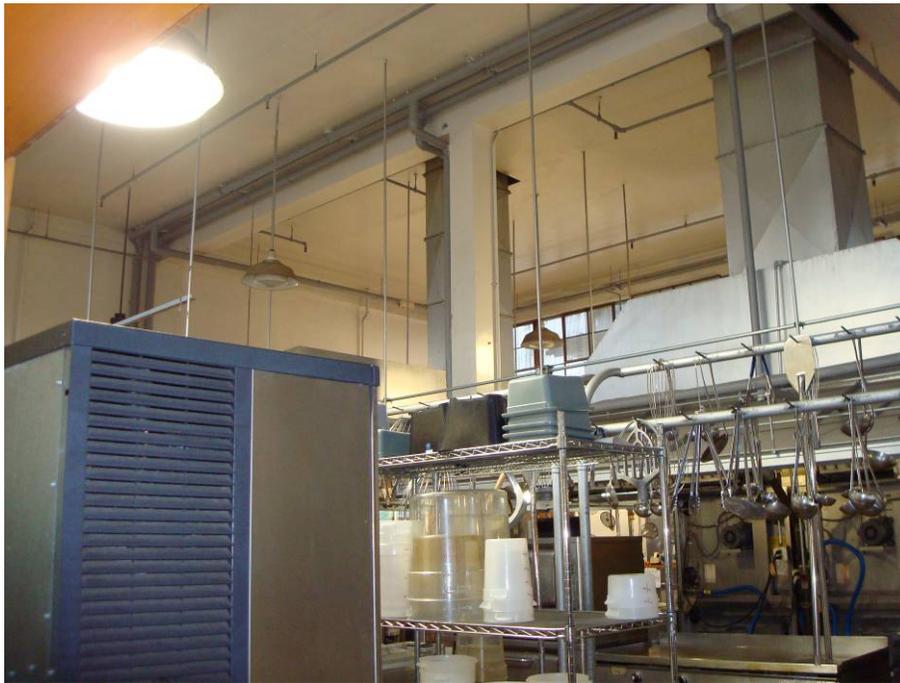
*Figure 24. Concrete gravity frame in Building 16.*

*Figure 25. Concrete Gravity Frames in Building 16.*

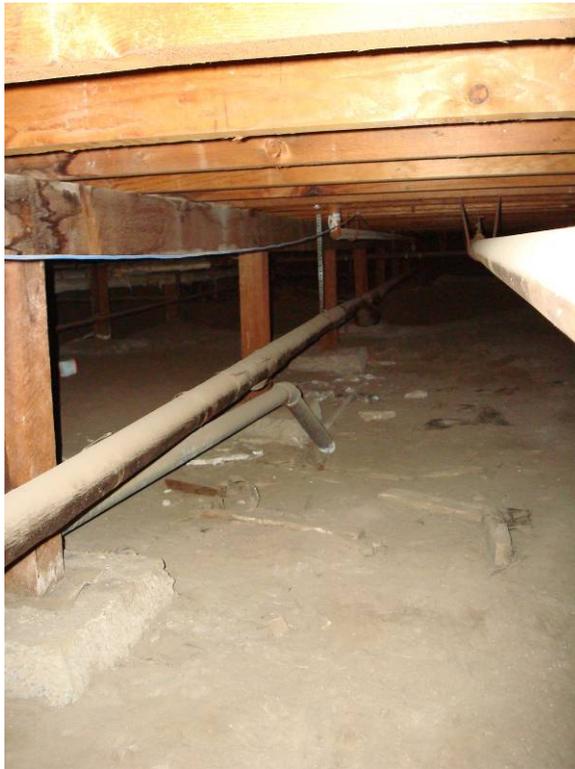
*Figure 7. Raised Floor in Building 2.*

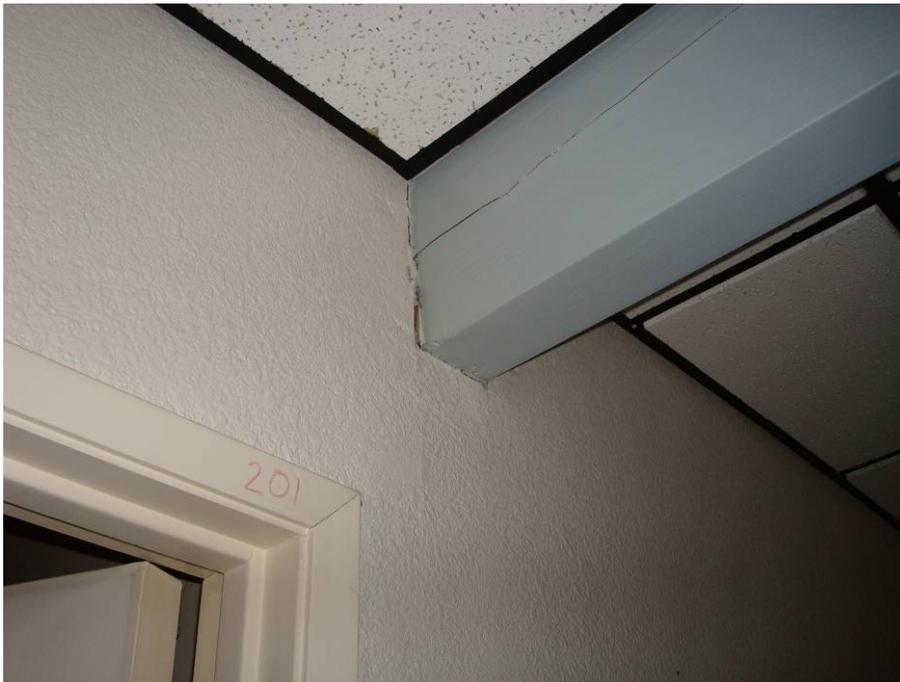
*Figure 8. Split Beam in Building 2.*

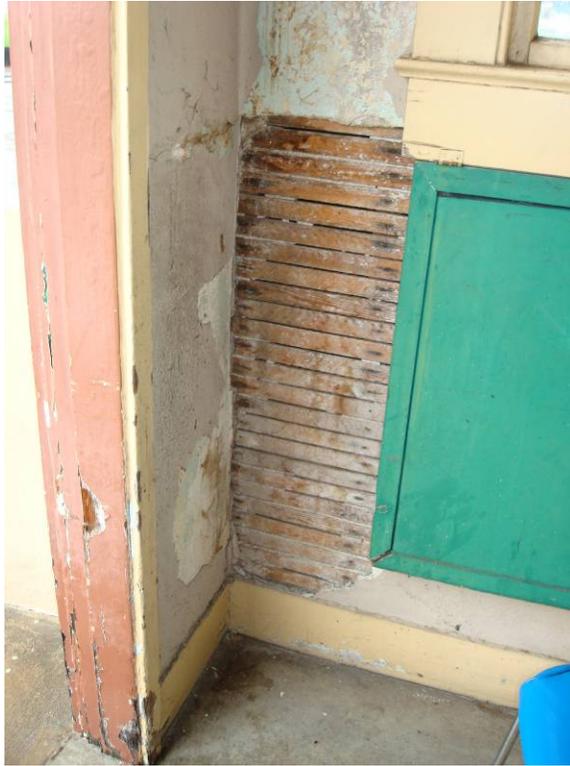
*Figure 11. Wood lath and stucco on exterior wall of Building 3.*

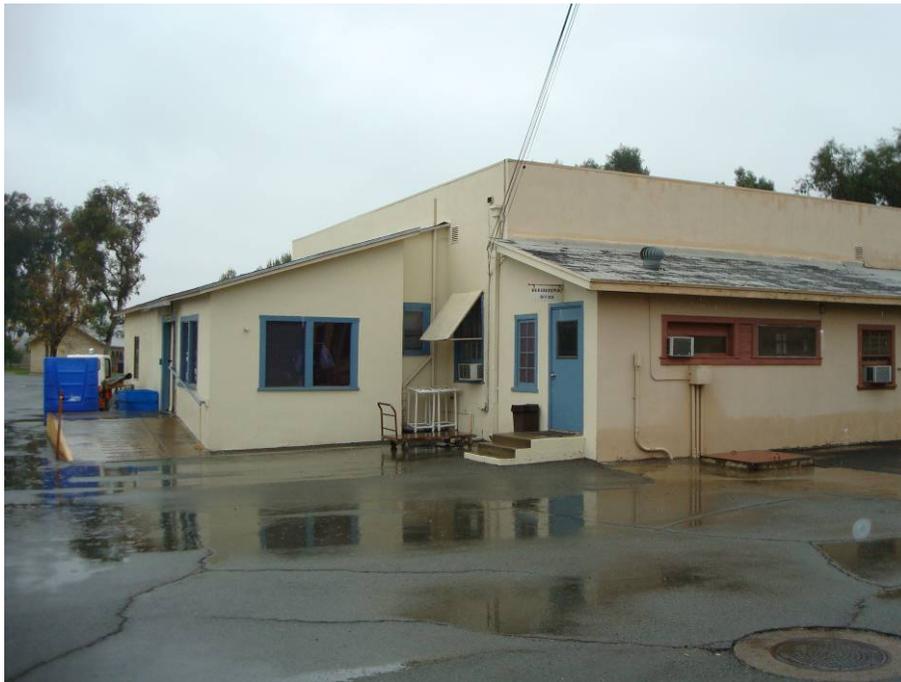
The overall condition of the building is generally fair for the current on-going operations, as further described in this section. The current mechanical, plumbing, and electrical systems are operative. There are signs of leaking from the flat roof in several locations (Figure 13). There are deficiencies with regard to updated ADA requirements; which include restroom facilities, door hardware, signage, and mounting heights of fixtures, where alternative provisions of the CHBC either do not apply or do not provide a significant cost savings advantage. There are two “lean-to” additions that were added to the original building that are not reflective of its original design (Figures 12 and 14).

*Figure 12. Shed Additions to Building 3.*

If the building were to be remodeled and brought up to current codes, while maintaining the original character of the era in which it was built, several items/systems would need to be corrected. The existing “lean-to” additions should be removed. The re-exposed exterior walls would need to be refinished. The exterior wood windows (Figure 15) shall either need to be retrofitted (if possible) to be dual-glazed for energy conservation conformance or replaced with dual glazed wood windows to match the existing windows. The exterior wood framed walls are in fair condition with minor cracking and spalling of the plaster on the surfaces. Only one area was found with significant failure (Figure 11). However, due to much of the requisite window retrofitting or replacement, patching and repair to where the “lean-to” additions are removed, the need for adding plywood panels (for code/structural shear requirements), and the need for adding R-19 insulation between the framing studs, it is recommended that the

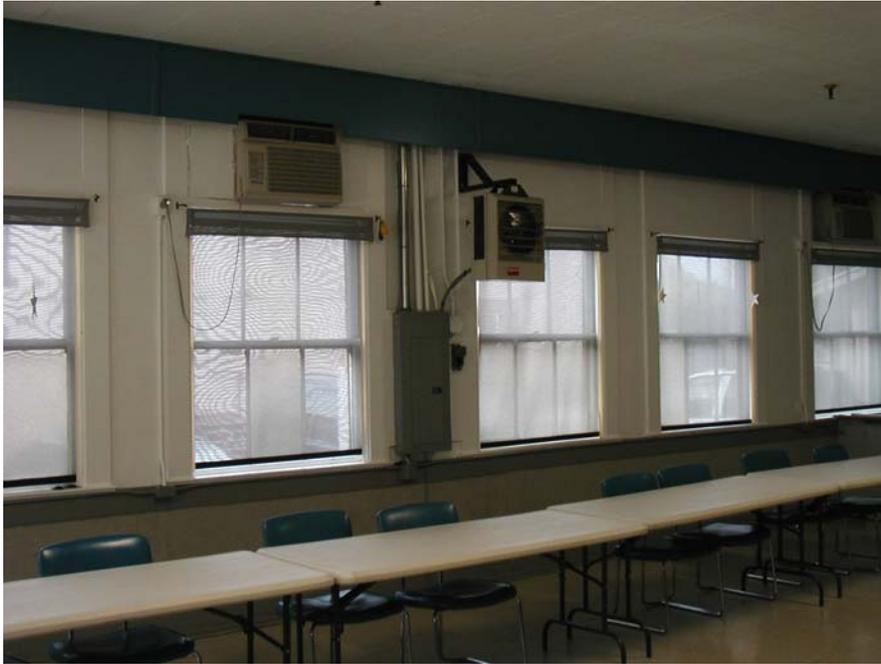
*Figure 17. View of AC System and Electrical Wiring of Building 3.*

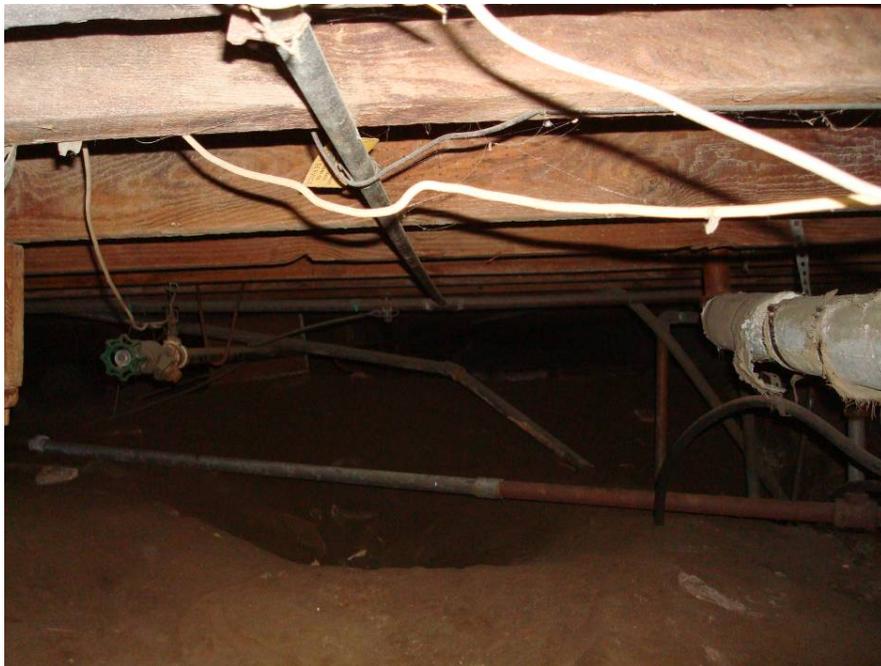
*Figure 18. Raised wood floor of Building 3.*

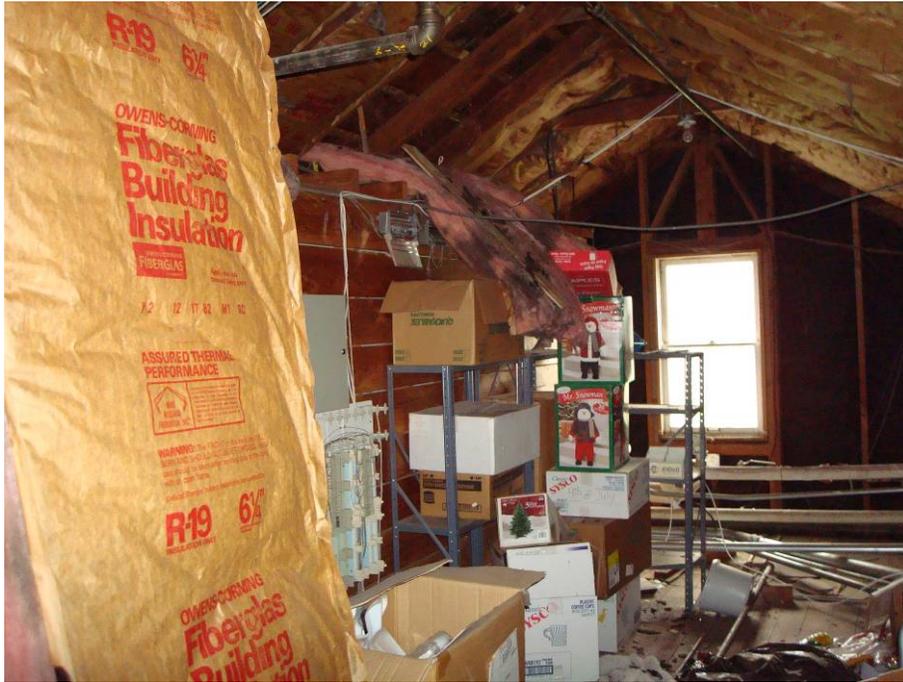
Figure 22. Interior view of attic of Building 8.

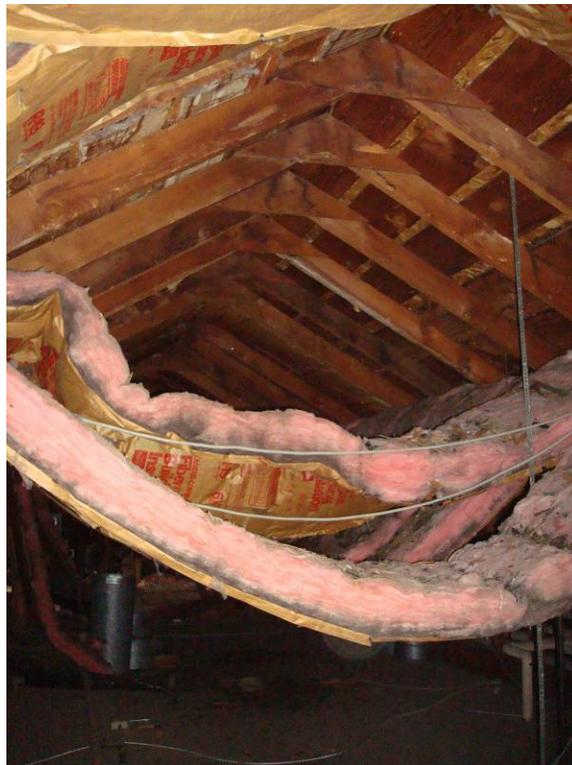
*Figure 24. Attic framing members with signs of water intrusion in Building 8.*

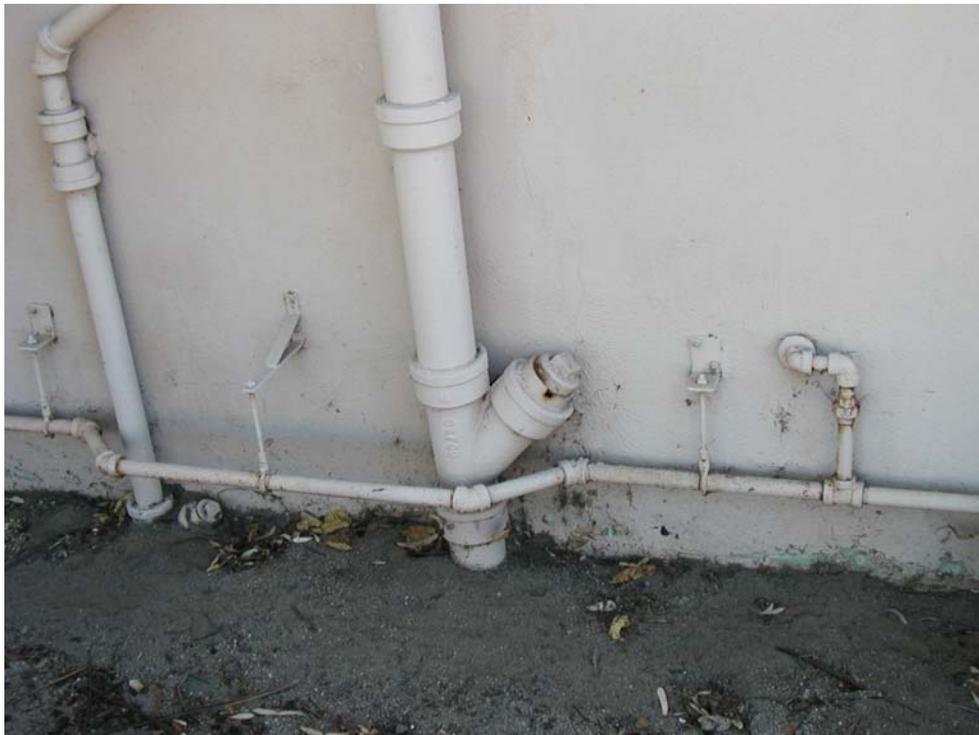
*Figure 28. View of Retrofitted Water System.*

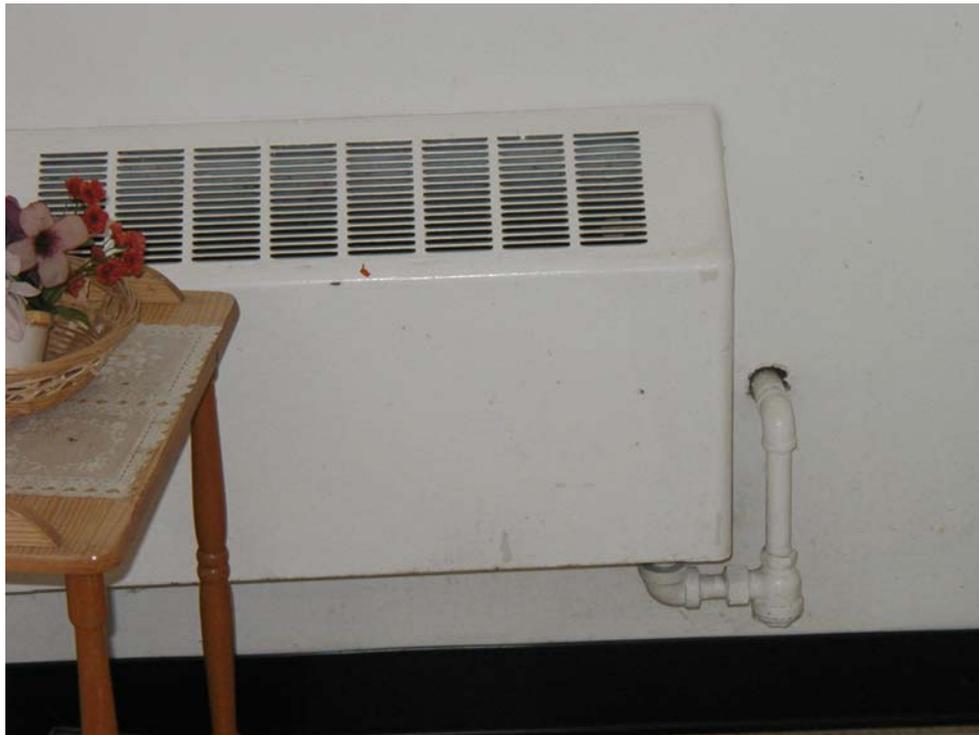
The interior finishes are in fair condition. However, as noted previously visual signs of asbestos were observed in ceilings, flooring, and piping insulation. Also, though the original steam supply for heating was abandoned, the original radiators and steam piping were left in place throughout the interior (Figures 31 & 34). The existing restrooms will require ADA upgrades, including, appropriate finishes for such use.

*Figure 31. View of Heating System.*

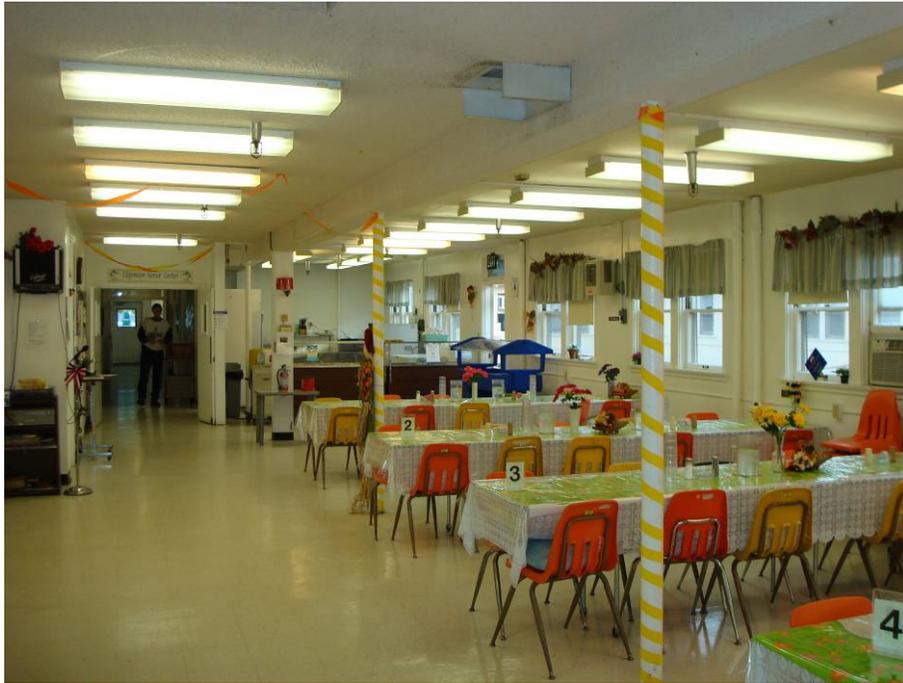
*Figure 41. Interior of Building 8 with steel pipe columns supporting the ceiling framing.*

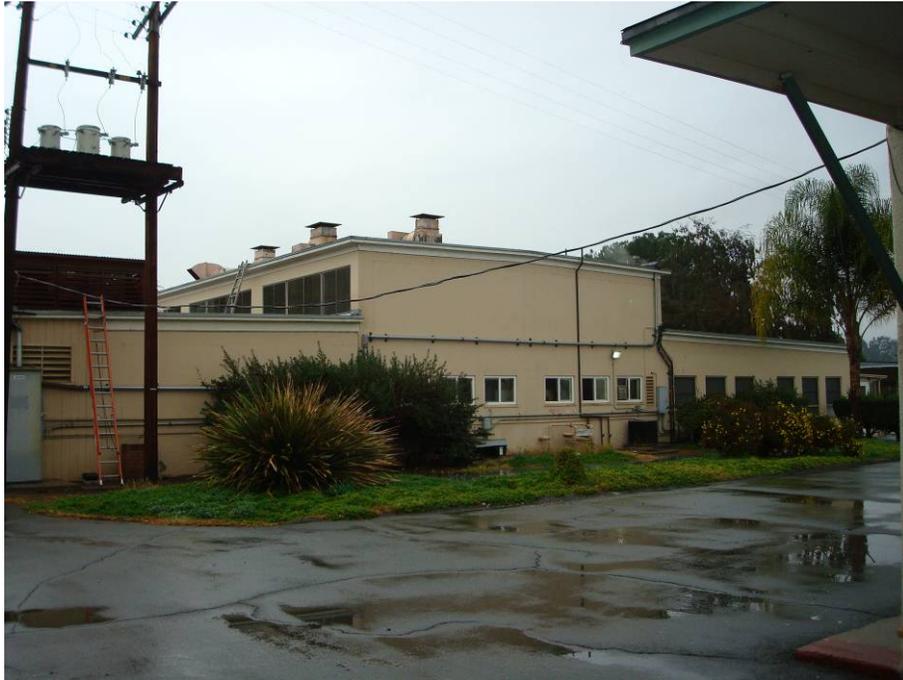
The building was constructed in 1951 by the County of San Diego Department of Public Works. It's original and current use is as a Dining Room and Kitchen for the Edgemoor Geriatric Hospital. The three-bay structure consists of two outer bays on either side of a single, high roofed middle bay (Figures 42 & 43). The roof height of the middle bay is approximately 20 feet. The building has a slightly sloped roof, peaked at the center with hot-mopped asphalt and gravel roofing material.

*Figure 42. Exterior view of Building 16.*

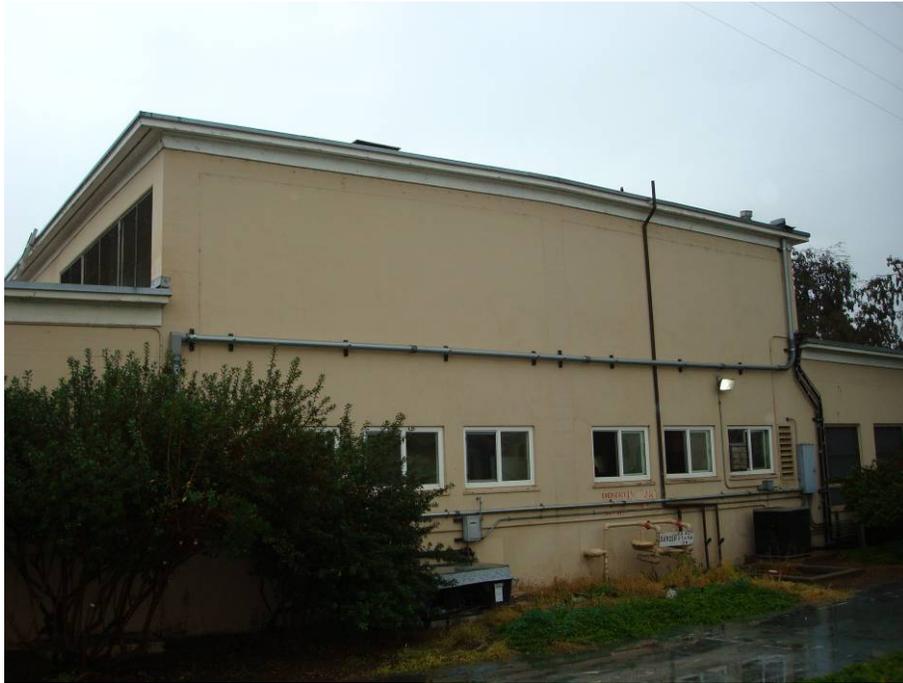
*Figure 43. Middle bay of Building 16.*

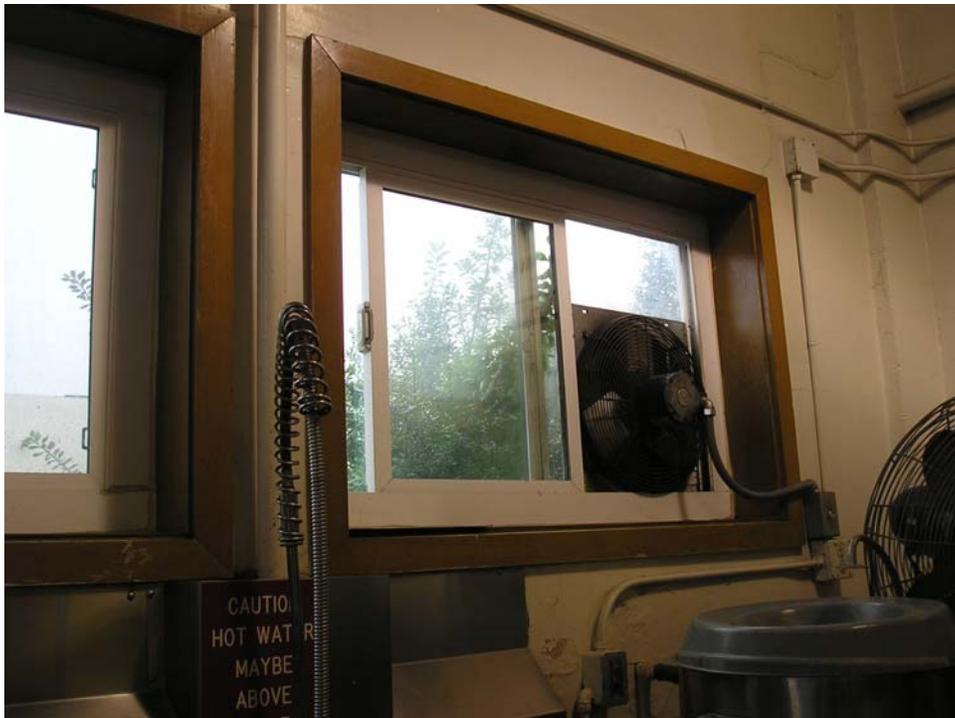
*Figure 46. View of Interior Wood Windows.*

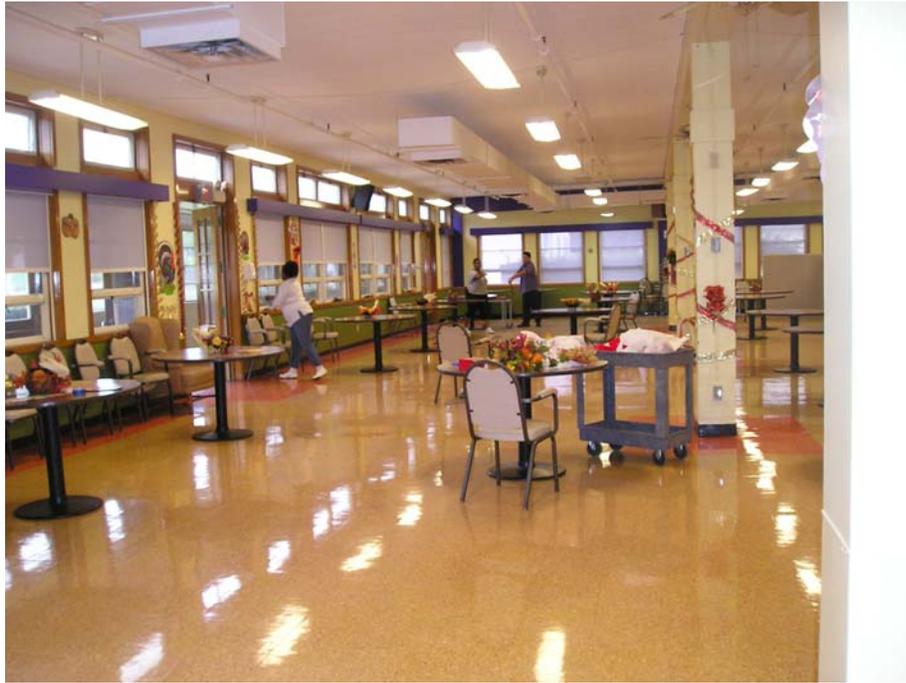
*Figure 47. View of Interior Finishes of Building 16.*

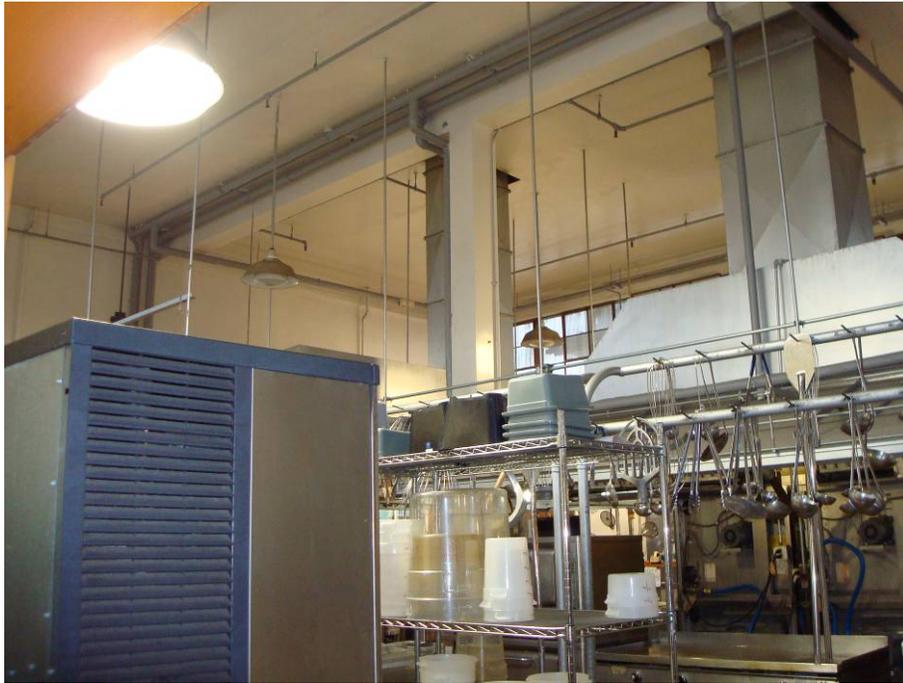
*Figure 53. Concrete gravity frame in Building 16.*

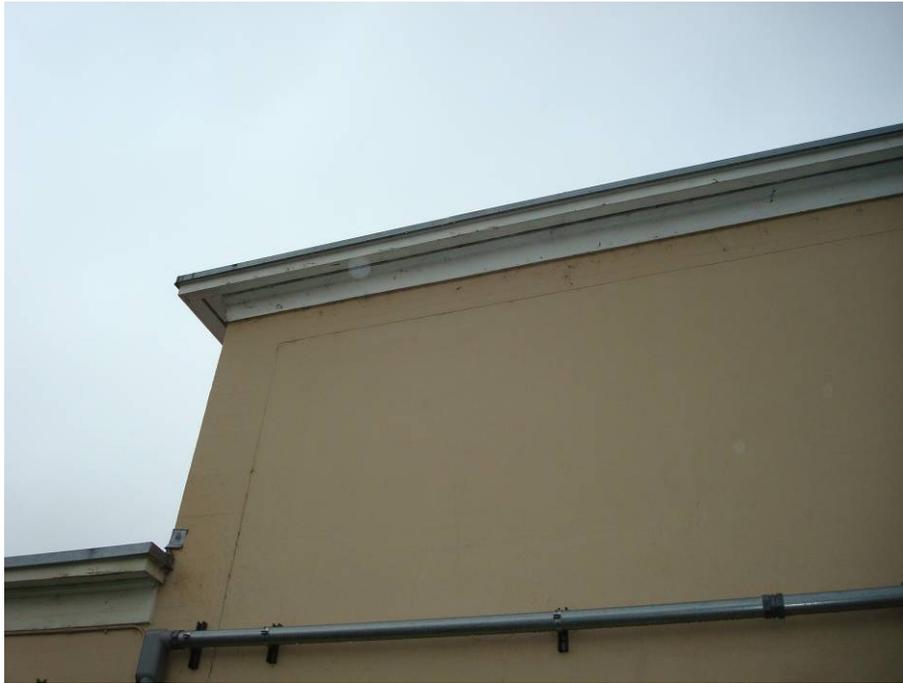
*Figure 55. Exterior concrete frame with infill walls in Building 16.*

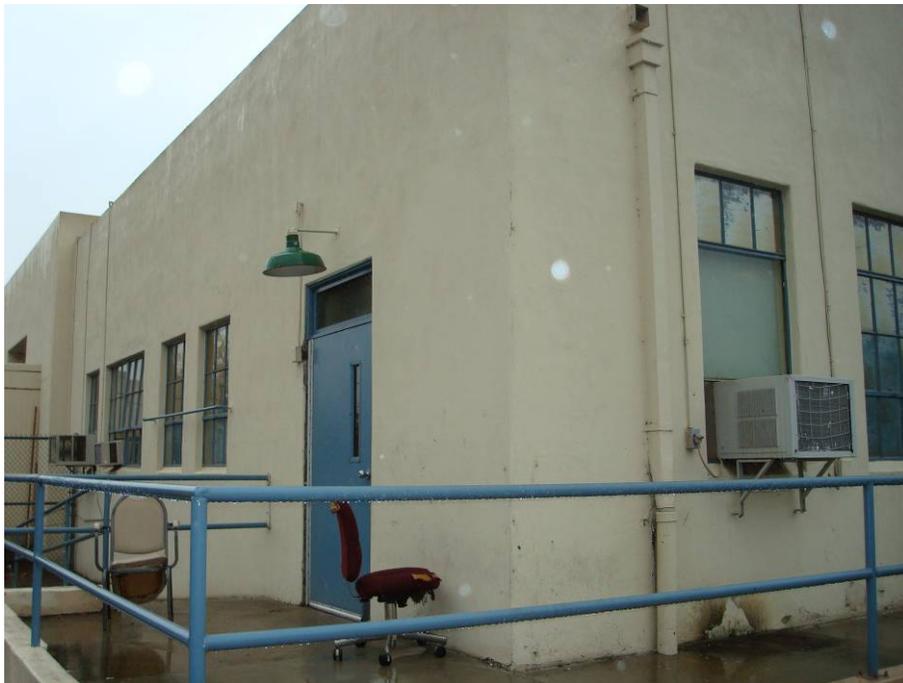
The building was constructed in 1945 as one of several buildings constructed for use by the County of San Diego as a sustainable farm facility which provided care of the aged, indigent, orphans and mentally ill. The historic use of the building was as Men’s and Women’s Custodial Wards. The building is currently utilized as a skilled nursing facility for head traumas and Huntington’s disease. The single story, U-shaped structure is constructed entirely of concrete with exterior stucco wall covering (Figure 56 & 57). The building’s flat roof consists of built-up asphalt roofing.

*Figure 56. Front view of Building 19 .*

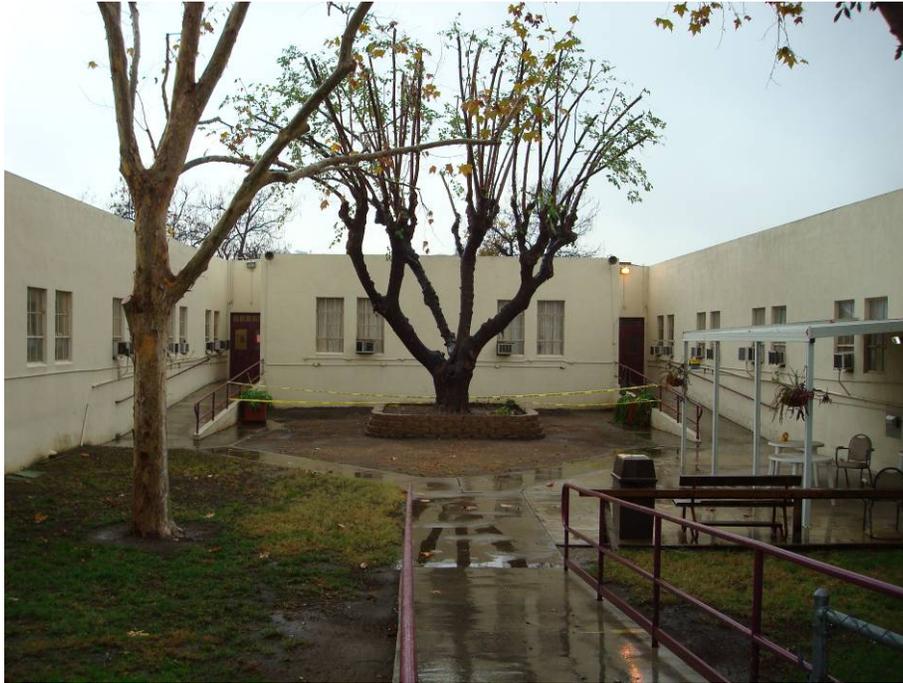
*Figure 57. Courtyard view of Building 19.*

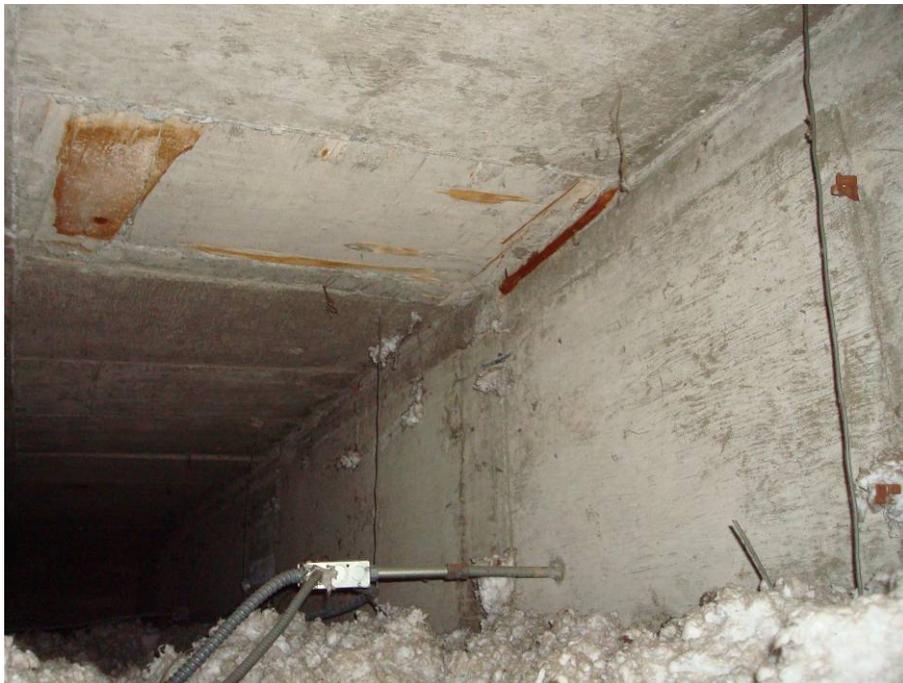
*Figure 58. Concrete roof slab supported by concrete walls of Building 19.*
